**SALFORD  
ARCHAEOLOGY**

## **Gazetteer of Features of Heritage Significance**

5<sup>th</sup> & 6<sup>th</sup> Floors,  
Islington Mill, Salford

# *Islington Mill Gazetteer of Features of Heritage Significance*

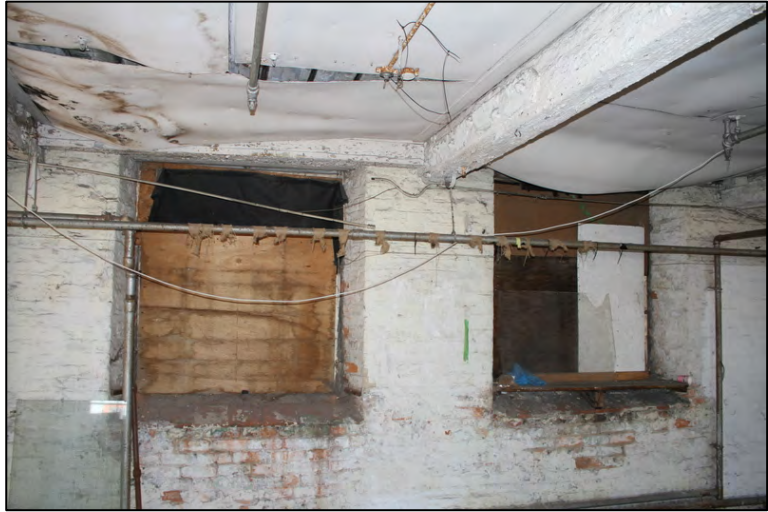
Feature Number: **5/01**

**Description:** The external walls of the 1823 mill are internally faced with handmade bricks, built in three-stretcher English Garden Wall bond. The brickwork is largely obscured by thick layers of paint and later fittings, but where it is exposed, it is bonded in a pale lime-based mortar.

**Assessment of Significance:** The walls form an integral element of the structure and are of HIGH significance. Interventions should ideally be kept to a minimum to preserve this important original fabric.

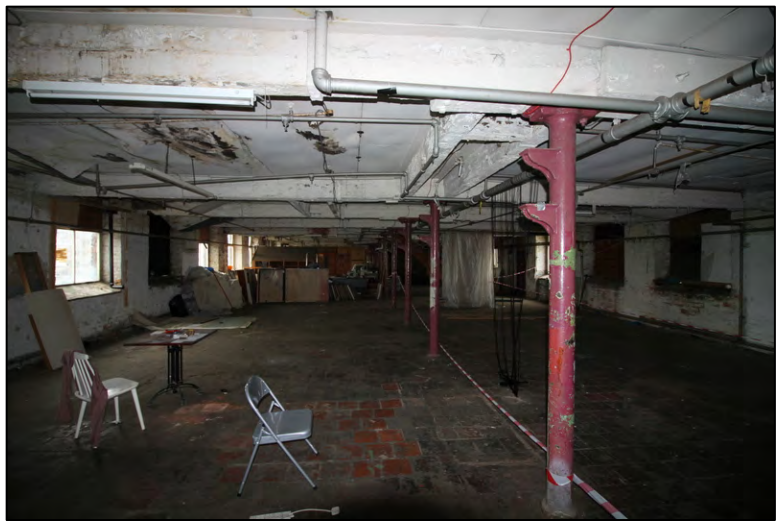
Feature Number: **5/02**

**Assessment of Significance:** The columns form an integral element of the structure and are of HIGH significance. Horizontal line-shaft carrier brackets are relatively rare, reflecting the early date of the columns, and the use of two such brackets is very uncommon. The significance of the columns is further enhanced by the accounts of the construction of the mill, where a collapse in 1824 was blamed on the failure of a cast-iron column.

Interventions should be avoided to preserve this important original fabric, and protection installed as appropriate during the work.

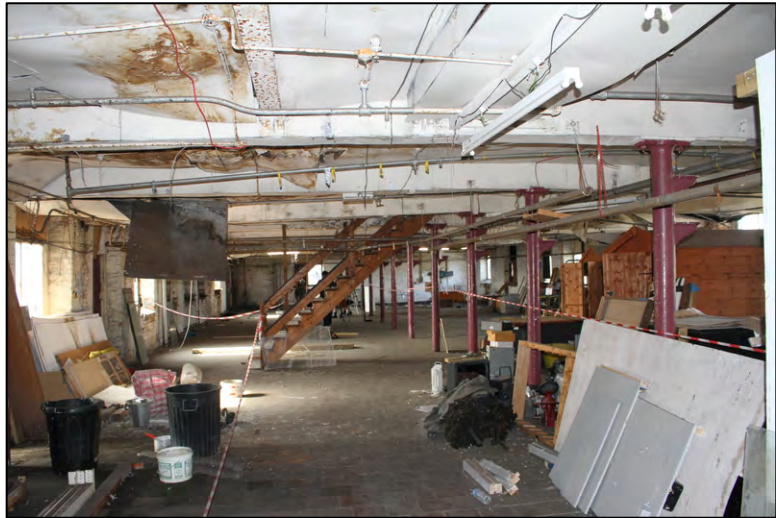
**Description:** Each bay division is spanned by a timber ceiling beam, supported at its mid-point by the cast-iron columns (5/02). These are of large scantling rectangular section, almost certainly of Baltic softwood, and typically of 7½" section. They are socketed into the long walls at either end, with no discernible pad, and appear to be butted by the timber window lintels. Each tie beam has stirrup straps to the queen posts above (Plate). Many of the beams were latterly shuttered, and several have been repaired or reinforced. Such interventions will be detailed for each individual beam.

**Assessment of Significance:** The timber ceiling beams represent the tie beams of the original roof trusses, and are thus an integral element of the structure and are of HIGH significance. The lower floors are of fireproof brick arch construction, meaning that Level 5 represents the only floor of the mill with flat ceilings and timber ceiling beams, typical of early textile mills.

Several of the timbers are in poor condition, and their repair has been included within the current project. These will be undertaken sympathetically, retaining as much original fabric as possible, whilst attempting not to obscure any significant detail. Cleaning of the timbers will be undertaken carefully to avoid damage to features identified on the beams.

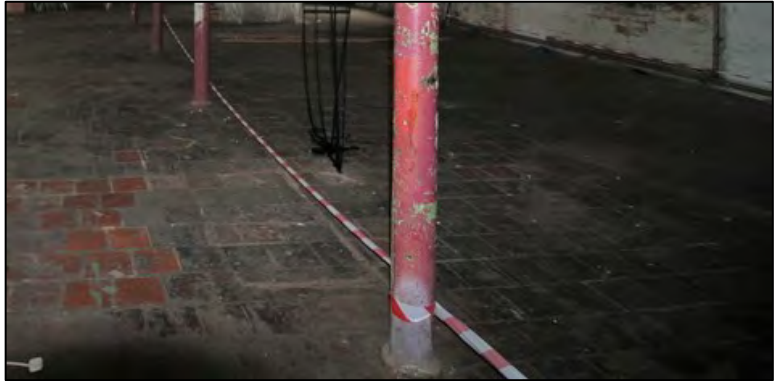
**Description:** The flooring of Level 5 comprises square quarry tiles of approximately 5" size and varying from an orangey red to almost black in colour. These overlay a make-up layer above the curved brick arches of the floor below and appear to underlie the column feet, suggest that they formed the original flooring of the mill. Their use within blocking of the original upright shaft bearing box suggest the re-use of salvaged tiles, rather than a complete reflooring of the whole floor at the time of the replacement of the original line shaft.

**Assessment of Significance:** The flooring is likely to represent the original flooring of the mill, and is therefore considered to be of HIGH significance.

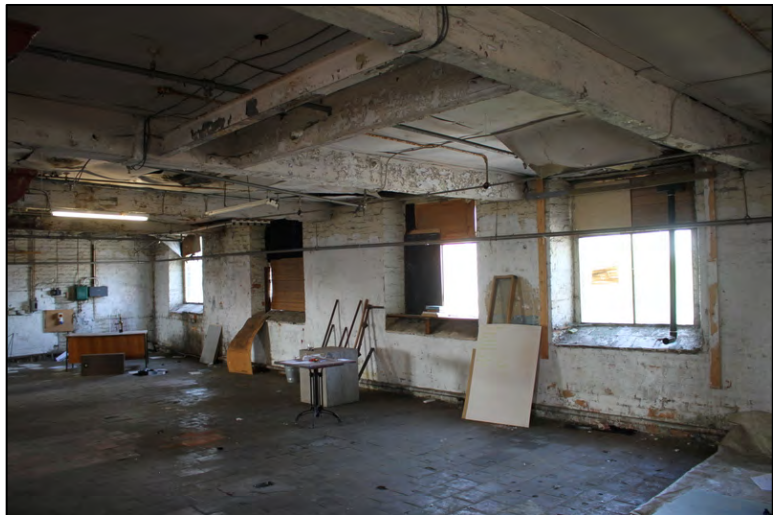
A window of similar style and proportions, set within the southern part of the west wall is almost certainly a contemporary original aperture.

**Assessment of Significance:** The window openings are largely intact and original, and therefore considered to be of HIGH significance, although all frames have been replaced and are of LOW significance.

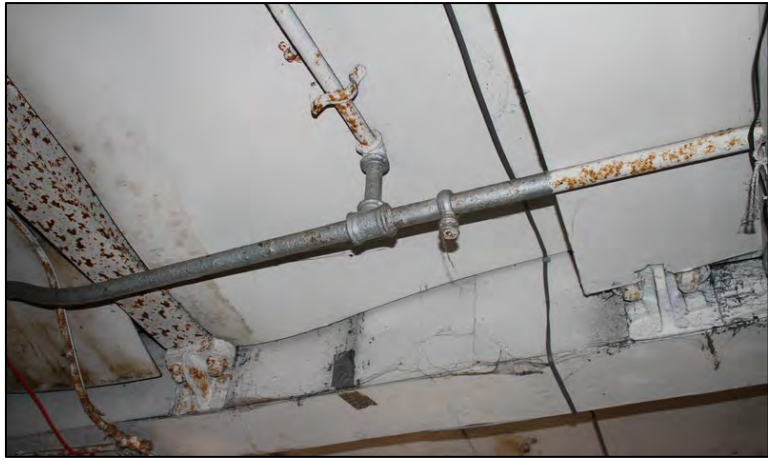
**Assessment of Significance:** The sprinkler system represents a well-preserved example of early-twentieth century fire-fighting apparatus found within many mills. Although an important feature of the mill from its installation, which would have been contemporary with the external fire escape, it is unremarkable in its design, and it is therefore considered to be of MEDIUM significance. Its retention would hamper the programme of repair works being undertaken, and it has therefore been recorded as part of a laser scan of the entire floor level prior to its removal.

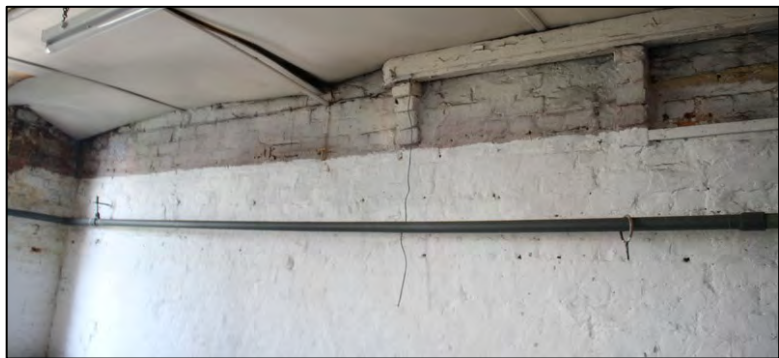
certainly of early-twentieth century origin, installed to create a suitable temperature and humidity for cotton spinning, in order to reduce breakages of the thread.

**Assessment of Significance:** As with the sprinkler system, heating pipes array were a common feature of cotton spinning mills in the region from the early twentieth century. However, their survival is less frequent than that of sprinkler systems, largely due to their lower placement within rooms making them inconvenient during reuse of buildings post cotton spinning. Given the relatively late date of the feature, the pipes are considered to be of MEDIUM significance, and like the sprinkler system, has been laser scanned prior to its removal during the repair works.

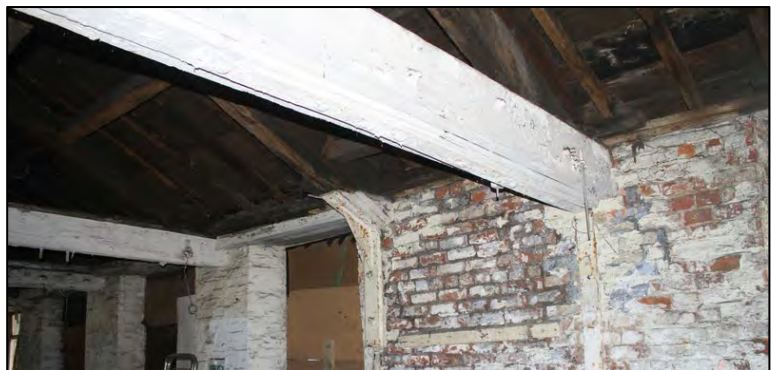
**Assessment of Significance:** These represent a repair to the decayed tie beam end, and are not thought to be early features, and are therefore considered to be of LOW significance.

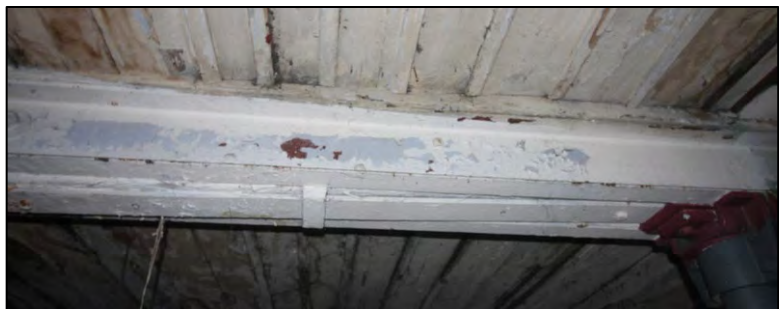
**Assessment of Significance:** This forms part of a repair to the decayed tie beam end, and is not thought to be an early feature, and is therefore considered to be of LOW significance.

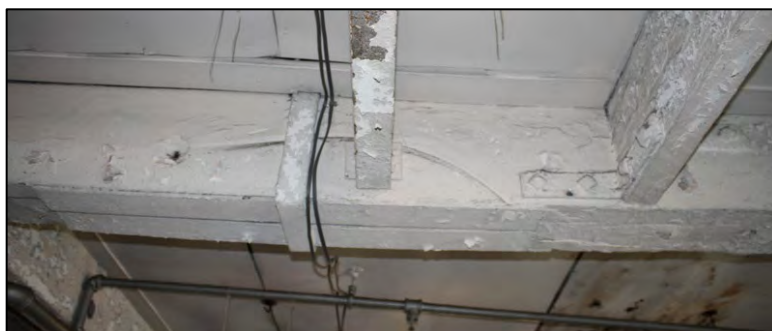
**Description:** A pair of flat rectangular metal plates bolted to soffit of the ceiling beam between Bays 3 and 4. These have been inserted between the beam and the stirrup to the queen post above, suggesting that there was significant damage to the beam to allow the plates to be manoeuvred into position.

**Assessment of Significance:** These represent a repair to the decayed tie beam end, but may be relatively early features, and are therefore considered to be of MEDIUM significance.

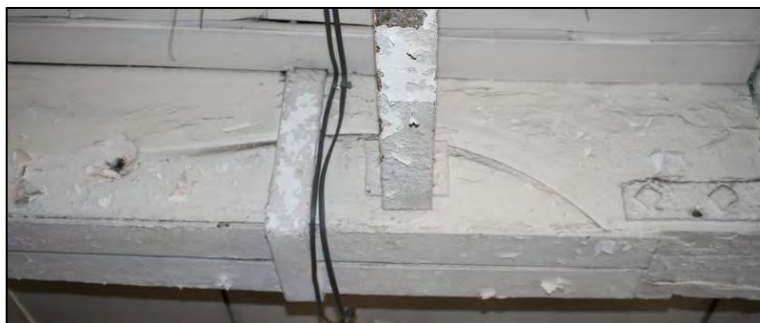
**Description:** A curving scar within the eastern face of the ceiling beam between Bays 3 and 4. It is unlikely to have been caused by the metal edge of a drum or roller, as it has an elongated run out at its southern side, more suggestive of being caused by a steel rope or possibly leather shafting belt.

**Assessment of Significance:** The scar probably represents evidence of the power transfer system. Possibly that originally provided to the 5<sup>th</sup> floor, and is therefore considered to be of HIGH significance.

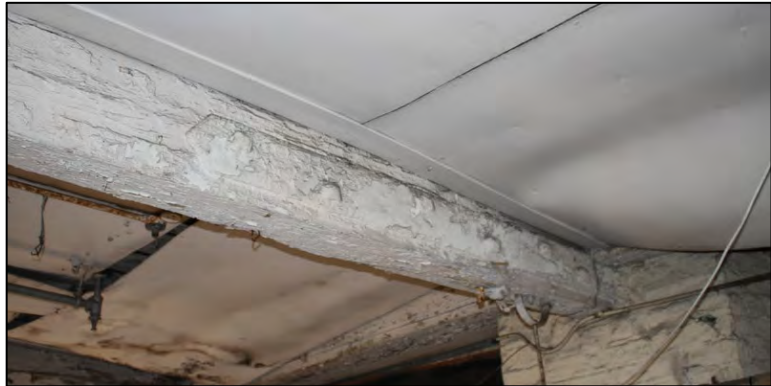
and are secured with several heavily painted square-headed bolts. Both are socketed into the south wall, and appear to be of relatively early date.

**Assessment of Significance:** The feature represents an early repair to the decayed tie beam end, and is therefore considered to be of MEDIUM significance.

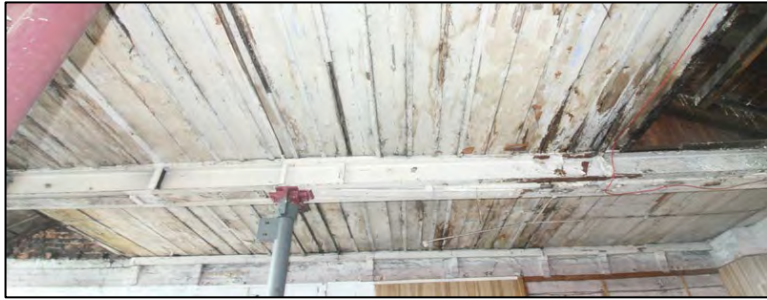
**Description:** A pair of rectangular channel-section steel flitch plates bolted to both faces of the ceiling beam between Bays 11 and 12. The beams are jointed above the column head, comprising two members to each side of the beam. Several rolling stamps bearing the name of the Frodingham Iron and Steel Co were observed, demonstrating the beams to be of 20<sup>th</sup> century date, and almost certainly associated with strengthening works to the eastern end of the roof structure undertaken during the installation of a new stair tower (**5/70**).

**Assessment of Significance:** These represent strengthening beams added to the tie beam of the eastern truss during the insertion of the early-20<sup>th</sup> century stair tower, and are therefore considered to be of LOW significance.

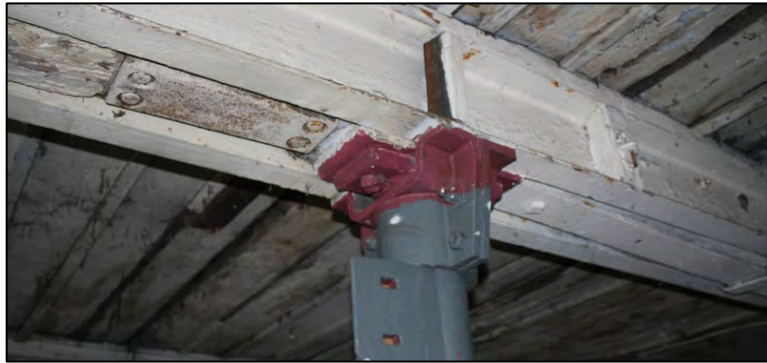
**Description:** A single narrow flat iron flitch plate bolted to soffit of the ceiling beam between Bays 11 and 12 immediately to the south of the column. It is placed above the stirrup of the southern queen post, either predating it, or signifying significant damage.

**Assessment of Significance:** This appears to represent an early strengthening of the eastern tie beam, and is therefore considered to be of MEDIUM significance.

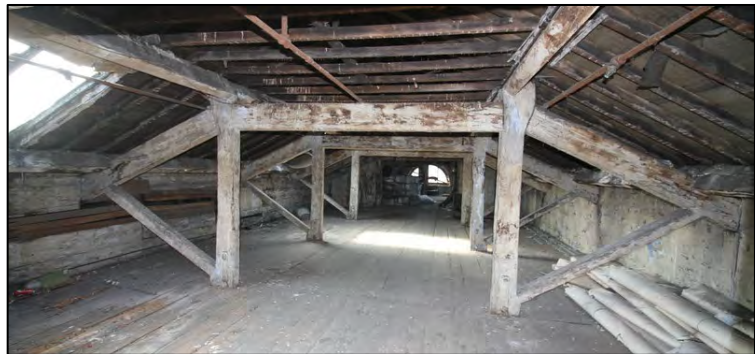
**Assessment of Significance:** The purlins form part of the original roof structure of the mill, and are of HIGH significance.

Several of the timbers are in poor condition, and their repair has been included within the current project. These will be undertaken sympathetically, retaining as much original fabric as possible, whilst attempting not to obscure any significant detail. Cleaning of the timbers will be undertaken carefully to avoid damage to features identified on the beams.

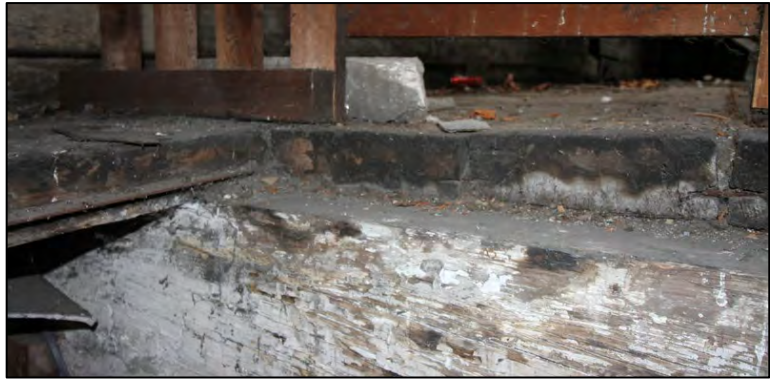
**Assessment of Significance:** The timber floor forms an integral element of the structure and is of HIGH significance. However, certain areas are in a poor state of repair, and the remodelling required to make the attic a viable space for future use requires the central void within the floor to be enlarged. The floor has been recorded to mitigate its loss, and where possible, original boards will be used to replace existing unsympathetic repairs. Further interventions should ideally be kept to a minimum to preserve this important original fabric.

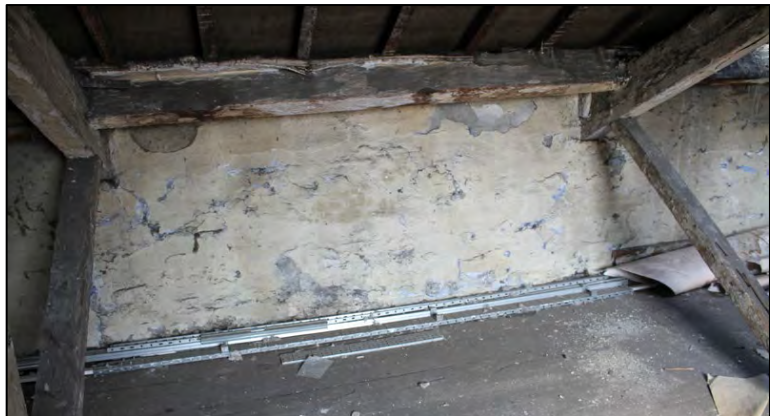
**Description:** The longitudinally, planked floor (**6/08**) was bounded by partition walls to both eaves. That on the northern side retained original lath and plaster walls, with damage revealing this to be of horse-hair and lime-based fabric. The southern eaves were partitioned by planks (**6/09**) and are described below, and probably represent a later remodelling.

**Assessment of Significance:** The plastered eaves partitions appear to represent an original element of the structure, and is therefore considered to be of HIGH significance. However, given the poor preservation of the roof timbers, and planking to the eaves floor, both eaves partitions must be removed. Their loss has been mitigated by 3D laser scanning and photographic recording.

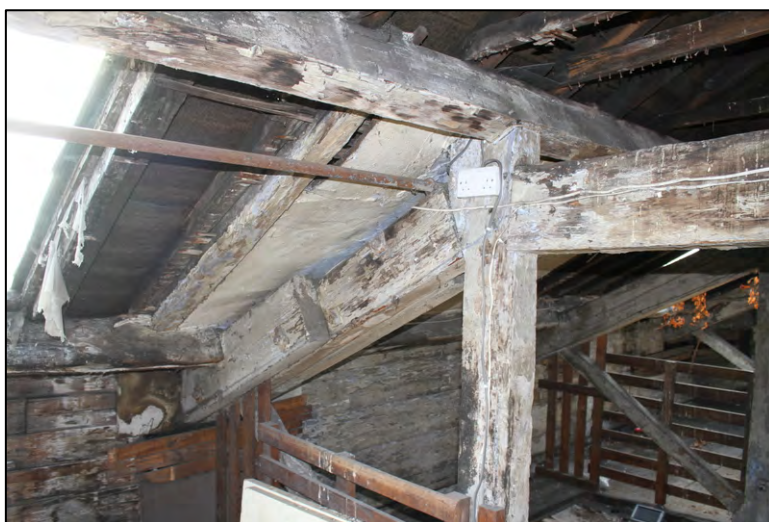
The feature represents a repair to the roof truss, but is of unclear date, possibly relating to the refurbishment of the roof in the early 1920s, and is therefore considered to be of MEDIUM significance.
