**SALFORD  
ARCHAEOLOGY**

## **Gazetteer of Features of Heritage Significance**

5<sup>th</sup> & 6<sup>th</sup> Floors,  
Islington Mill, Salford

# *Islington Mill Gazetteer of Features of Heritage Significance*

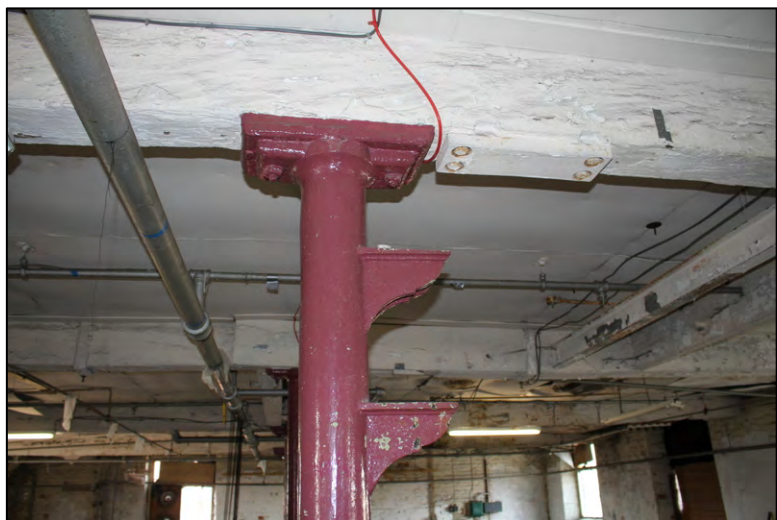
Feature Type: Metal plate

**Description:** Each tie beam has a steel/ plate bolted into the soffit, immediately adjacent to the column, on its eastern side. These are 17" long, and secured by four hexagonally-headed bolts, and cover pairs of small square cut-outs in the soffit of each beam, typically 2" wide, 1" deep, and set 9" apart. These appear to relate to line shaft hanger brackets, and are aligned with a 2ft wide bearing

box in the west wall, which represented the end bearing for an inserted line shaft, replacing the original shaft that ran adjacent to the columns, and was inserted after 1828.

**Assessment of Significance:** The brackets provide good evidence for the power system within the mill, albeit within a secondary phase. Although the hangers themselves have been removed, the extant brackets and associated cut-outs in the tie beams are of HIGH significance.

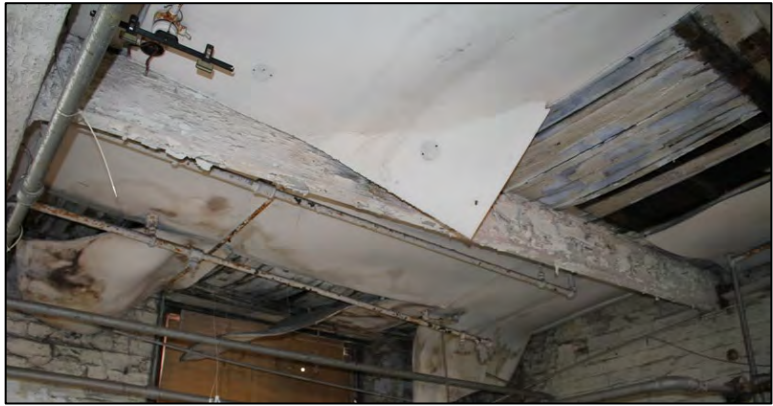
Feature Type: Ceiling beam

**Description:** An east/west aligned narrow ceiling beam, placed at the mid-point of the eaves above in the southern part of the bay. Socketed into the brickwork of the west wall, and hung onto the tie beam to the east with a cast-iron shoe. Possibly relates to the insertion of a hoist into the attic (**5/14**), and may form a pair with Feature **5/10**, placed in a similar position in the northern part of the bay.

**Assessment of Significance:** The precise function of the beam is unknown, but it appears to be of relatively early, or possibly original date, and is therefore considered to be of MEDIUM significance.

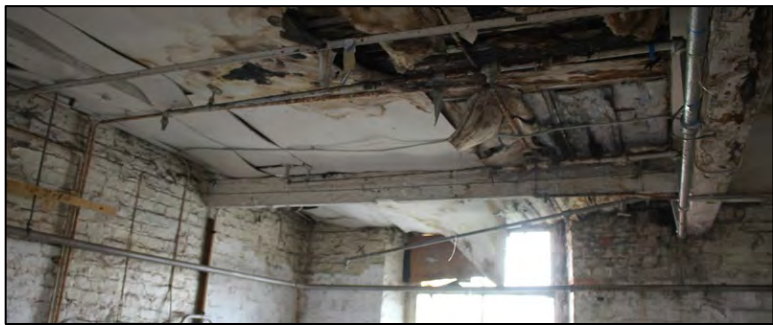
Feature Type: Ceiling beam

**Description:** An east/west aligned narrow ceiling beam, placed at the mid-point of the eaves above in the northern part of the bay. Socketed into the brickwork of the west wall and hung onto the tie beam to the east with a cast-iron shoe. Possibly forms a pair with Feature **5/09**, placed in a similar position in the southern part of the bay.

**Assessment of Significance:** The precise function of the beam is unknown, but it appears to be of relatively early, or possibly original date, and is therefore considered to be of MEDIUM significance.

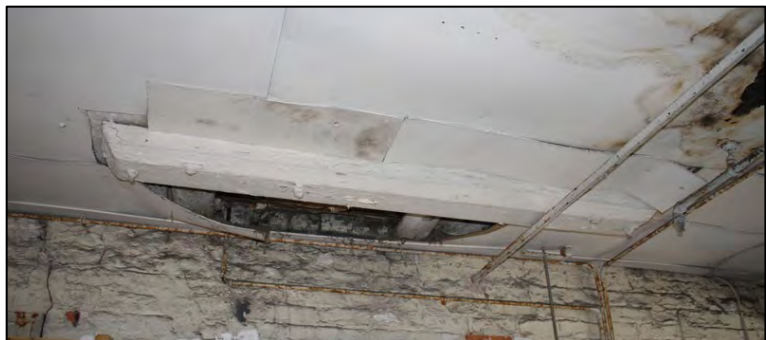
Feature Type: Ceiling beam

**Description:** A north/south aligned narrow ceiling beam, placed within the northern part of the bay, adjacent to the gable wall. The beam is chamfered on its eastern face, suggesting that it was intended as a long-term fixture, bolted from the floor above at either end. Possibly relates the hanging of a short line shaft or pulley associated with the hoist inserted into the southern part of the bay (**5/14**).

**Assessment of Significance:** The precise function of the beam is unknown, but it appears to be of relatively early, or possibly original date, and is therefore considered to be of MEDIUM significance.

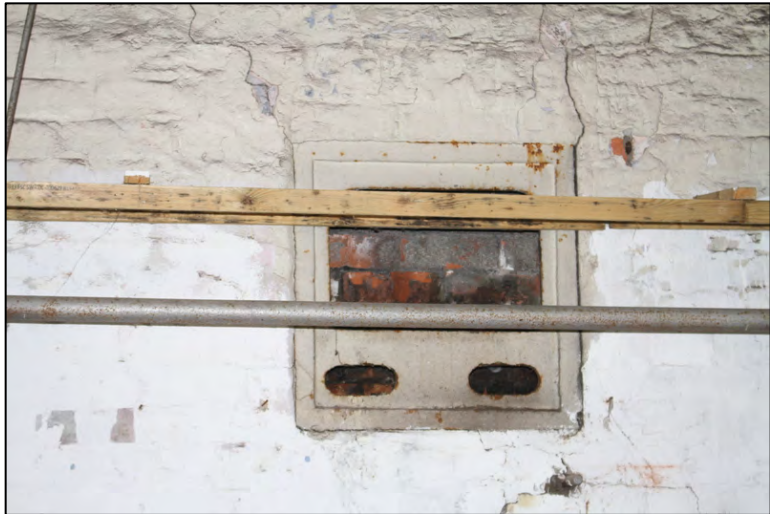
Feature Type: Bearing box

**Description:** A cast-iron bearing box set within the western gable wall. It formed the end bearing for a line shaft, and is of a style typical of the mid/late 19<sup>th</sup> century, representing the only extant evidence for significant modifications to the principal line shafting system within the mill undertaken following the repositioning of the engine house after 1828, but probably significantly later.

**Assessment of Significance:** The bearing box provides good visual evidence for modifications to the power system within the mill, and is therefore considered to be of HIGH significance.

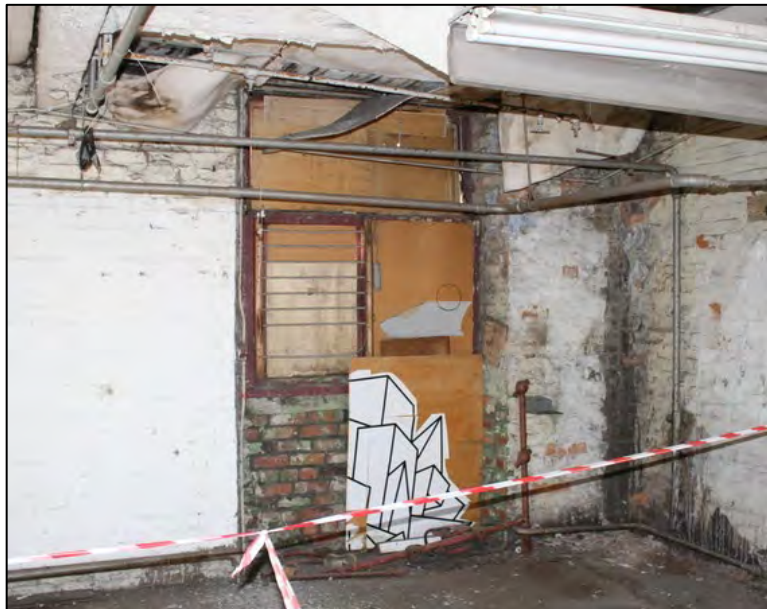
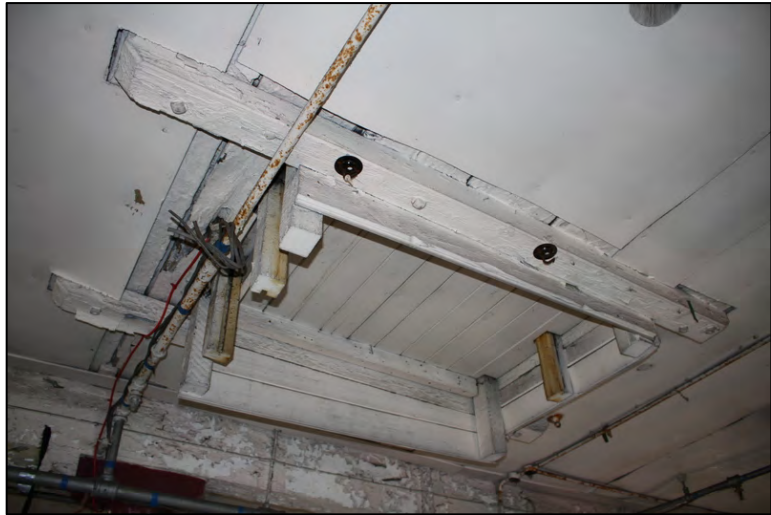
Feature Number: **5/14**

**Description:** A hoist between the 5<sup>th</sup> and 6<sup>th</sup> floors, placed in the southern part of the western bay. It has substantial chamfered timbers forming its eastern and western sides, with a framework of tongue-and-grooved planking projecting through the ceiling on a frame of square posts. The aperture between floors also has an *in-situ* tongue-and-grooved plank cover.

**Assessment of Significance:** The feature represents an insertion, probably in the late-19<sup>th</sup> or early 20<sup>th</sup>-century, although the housing may be for an earlier opening between the two floors. The hoist mechanism above (**6/\*\***) survives intact, increasing the importance of the aperture between the two floors, and it is therefore considered to be of MEDIUM significance.

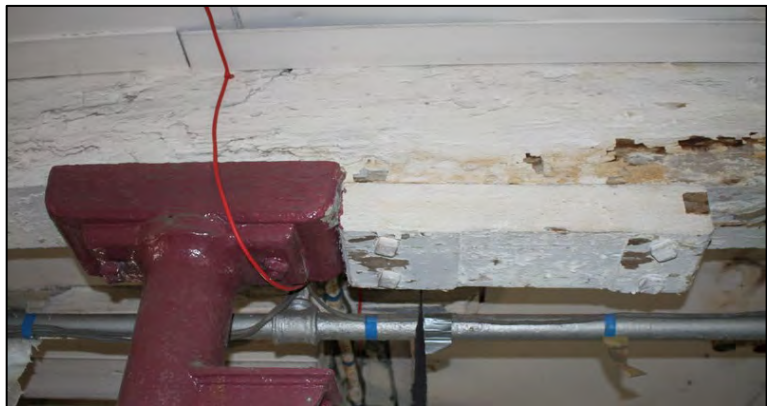
Feature Type: Ceiling beam pad

**Description:** The plate adjacent to the column of the western tie beam is not metal, as elsewhere, but comprises a thick timber pad, bolted into the soffit of the beam by four square-headed bolts. It has a wide compression mark in its soffit, suggesting that it may have formed the pad between a post and the tie beam prior to the relocation of the main line shaft to the north of the column line, in line with bearing box **5/12**.

**Assessment of Significance:** The precise function of the pad is unknown, but it appears to be of relatively early, or possibly original date, and is therefore considered to be of MEDIUM significance.

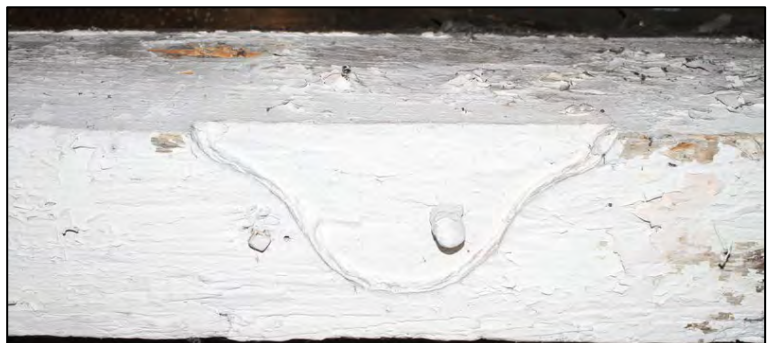
Feature Type: Cut-out / compression scar

**Description:** A round-headed, ogee profile cutaway in the soffit of the western tie beam, towards its southern end, and of

approximately  $\frac{3}{4}$ " depth. It has a solitary bolt thread protruding from its southern end, and probably formed the base of an L-shaped bracket attached to the beam. Similar style and size to feature **5/17**, located on the same beam to the north.

**Assessment of Significance:** The precise function of the pad is unknown, but it appears to be of relatively early, or possibly original date, and is therefore considered to be of MEDIUM significance.

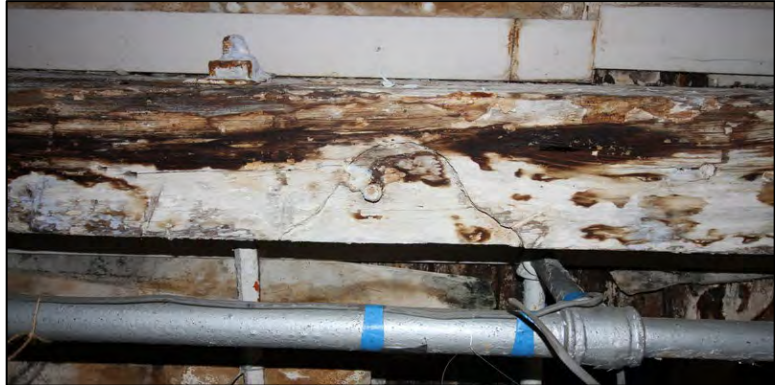
Feature Type: Cut-out /  
compression scar

**Description:** A round-headed, ogee profile cutaway in the soffit of the western tie beam, in the northern part of the bay, and of approximately  $\frac{3}{4}$ " depth. It has a solitary bolt thread protruding from its southern end, and probably formed the base of an L-shaped bracket attached to the beam. Similar style and size to feature **5/16**, located on the same beam to the south.

**Assessment of Significance:** The precise function of the pad is unknown, but it appears to be of relatively early, or possibly original date, and is therefore considered to be of MEDIUM significance.

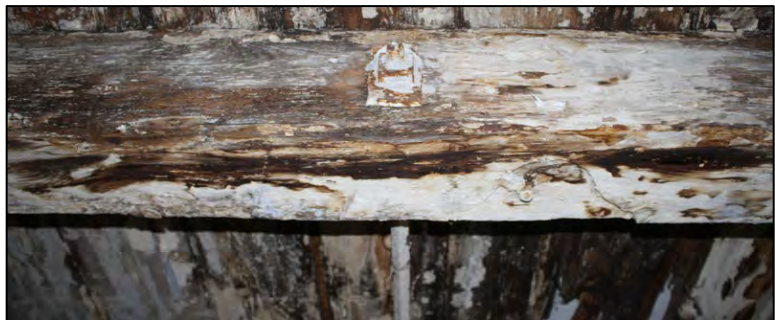
Feature Type: Timber mark

**Description:** A well-defined Baltic timber mark on the eastern face of the ceiling beam between Bays 1 and 2.

The mark demonstrates that the timber is Baltic softwood, and is therefore considered to be of HIGH significance.

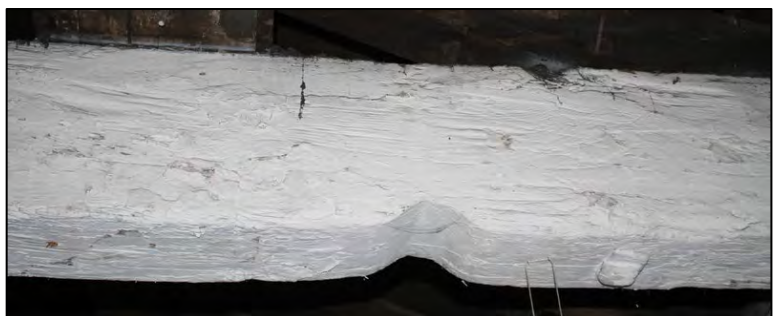
Feature Type: Cut-out /  
compression scar

**Description:** A rounded, cutaway in the soffit of the tie beam between Bays 2 and 3. in the northern part of the bay.

**Assessment of Significance:** The precise function of the cut-out is unknown, but similar features observed in earlier mills would normally be associated with the power transfer system. It appears to be of relatively early, or possibly original date, and is therefore considered to be of HIGH significance.

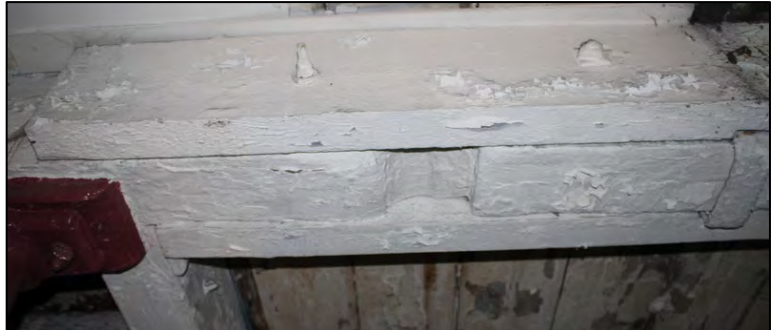
Feature Type: Cut-out /  
compression scar

**Description:** A rounded, cutaway in the soffit of the tie beam between Bays 2 and 3, in the central part of the bay. More crudely formed than **5/19** to the north, and became redundant following the strengthening of the tie beam with the addition of timber flitch plates **5/21**.

**Assessment of Significance:** The precise function of the cut-out is unknown, but similar features observed in earlier mills would normally be associated with the power transfer system. It appears to be of relatively early, or possibly original date, predating a timber repair to the beam, and is therefore considered to be of HIGH significance.

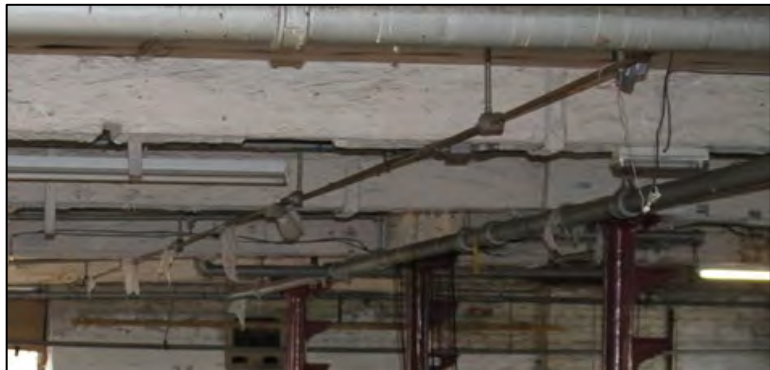
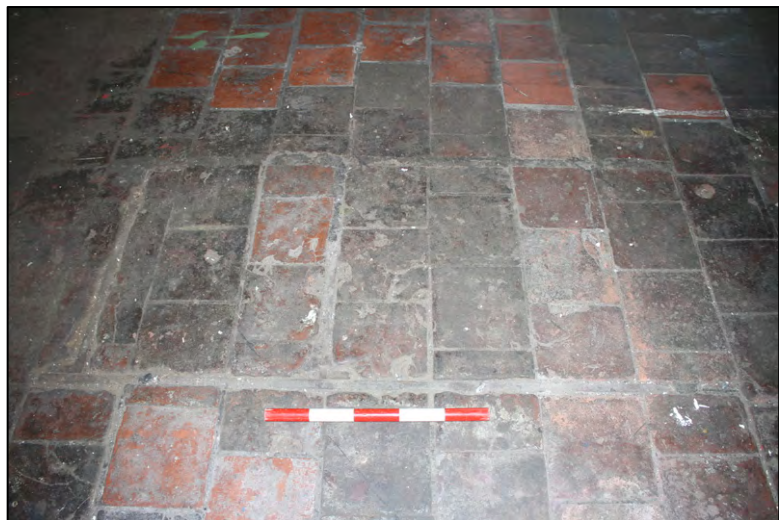
Feature Number: **5/24**

**Description:** A cast-iron bearing box set within the floor of the 5<sup>th</sup> floor, and infilled by re-used quarry tiles. This represents the bearing box for the upright shaft, which passed vertically between floors within Bay 3, adjacent to the wall of the engine house that was incorporated into the western two bays of the mill at a lower level.

**Assessment of Significance:** Although infilled, the bearing box is an integral part of the original power system within the mill, and is therefore considered to be of HIGH significance.

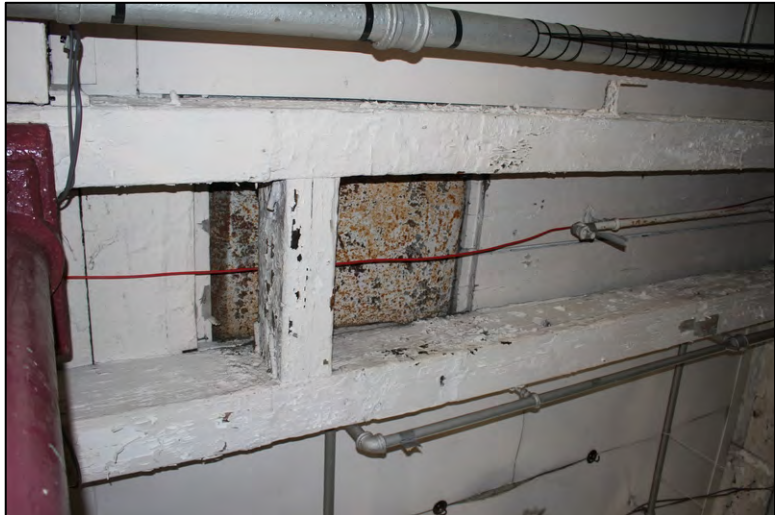
Feature Type: Bearing box

**Description:** Timber framing for the upright shaft in the ceiling of Bay 3, comprising two large scantling longitudinal beams. And a shorter cross member that would have housed a bearing to stabilise the shaft, and probably form the offtake bevel for the 5<sup>th</sup> floor.

The framing forms an integral part of the original power system within the mill, and is therefore considered to be of HIGH significance.

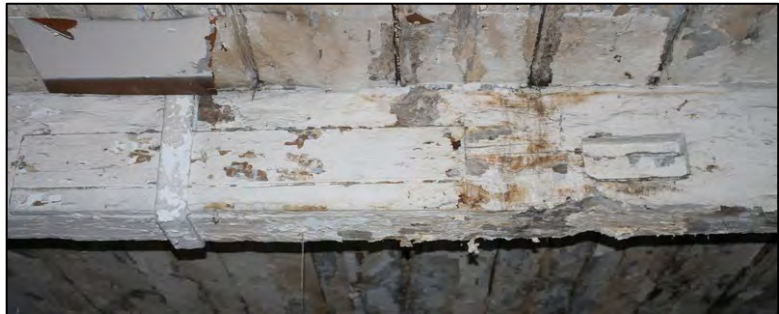
Feature Type: Cut-out /  
compression scar

**Description:** A rectangular, cutaway in the east face of the beam between Bays 2 and 3, with a larger infilled rectangular cutaway to the south, and a slight rounded cutaway in the soffit of the beam immediately below. Possibly associated with the upright shaft bearing.

**Assessment of Significance:** The precise function of the cut-outs is unknown, but similar features observed in earlier mills would normally be associated with the power transfer system. It appears to be of relatively early, or possibly original date, and is therefore considered to be of HIGH significance.

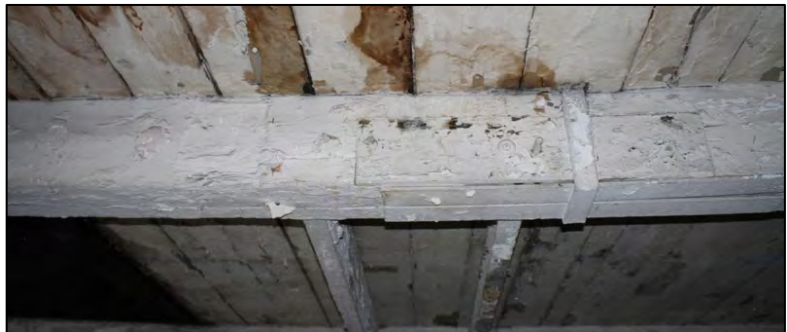
Feature Type: Cut-out /  
compression scar

**Description:** A rectangular cutaway in the west face of the tie beam between bays 3 and 4, in the northern part of the bay. It is of similar size to that in the opposite face of the beam to the west (5/26), but not aligned, and also has a timber infill. A vertical compression scar in the face of the beam, immediately to the north may form part of the feature.

**Assessment of Significance:** The precise function of the cut-out is unknown, but similar features observed in earlier mills would normally be associated with the power transfer system. It appears to be of relatively early, or possibly original date, and is therefore considered to be of MEDIUM significance.

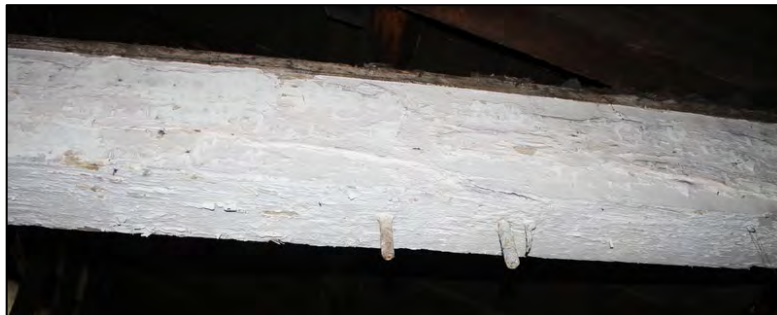
Feature Type: Fixing bolts

**Description:** Pair of threaded iron bolts projecting from the soffit of the beam between Bays 3 and 4, close to the southern wall. This

arrangement is typical of the attachment for J-shaped line shaft hangers, and the position relative to the long wall of the mill is also typical. However, little evidence for a shaft in this position was observed elsewhere on the 5<sup>th</sup> floor.

**Assessment of Significance:** The bolt pair provides evidence for the position of a possible line shaft within the 5<sup>th</sup> floor, and is therefore considered to be of HIGH significance.

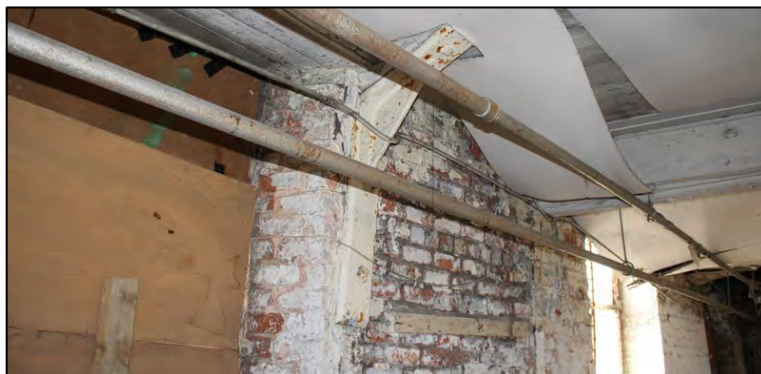
Feature Type: Bracket

**Description:** An L-section angled cast-iron foot bracket for an additional rafter within Bay 3, immediately to the west of the window in the south wall. It is fixed with square-headed bolts and relates to the insertion of a skylight window within the roof above. Probably of late-19<sup>th</sup> or early 20<sup>th</sup> century date.

**Assessment of Significance:** This forms part of an insertion to the southern pitch of the roof, and is not thought to be an early feature, but is considered to be of MEDIUM significance.

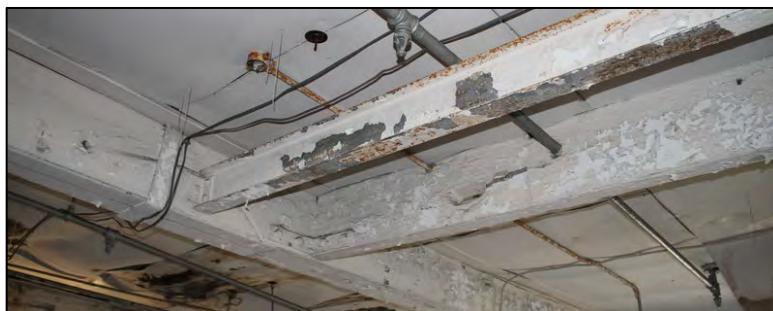
Feature Type: Ceiling beam

**Description:** An east/west aligned, narrow timber ceiling beam, placed across the northern part of the bay. The beam is fixed with L-section

cast-iron brackets and square-headed bolts to either face at either end, and is probably associated with a drum scar (**5/33**) to the south

**Assessment of Significance:** The precise function of the beam is unknown, but it appears to be of relatively early, or possibly original date, and is therefore considered to be of MEDIUM significance.

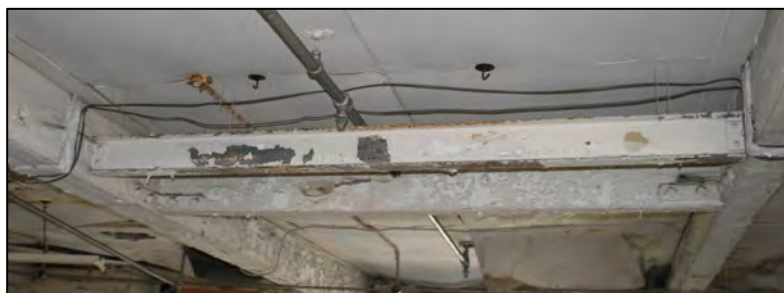
Feature Type: Ceiling beam

**Description:** An east/west aligned narrow I-section steel ceiling beam, placed across the northern part of the bay, to the south of timber beam **5/30** to the immediate north. The beam is fixed with square-headed bolts to either face at both ends, and is possibly associated with a pair of flitch plates on the soffit of the western ceiling beam (**5/32**) to the south. It blocks what appears to be a drum scar (**5/33**) on the east face of the west beam, further suggesting a relatively late date of insertion.

**Assessment of Significance:** The precise function of the beam is unknown, but it appears to be of relatively late date, and is therefore considered to be of LOW significance.

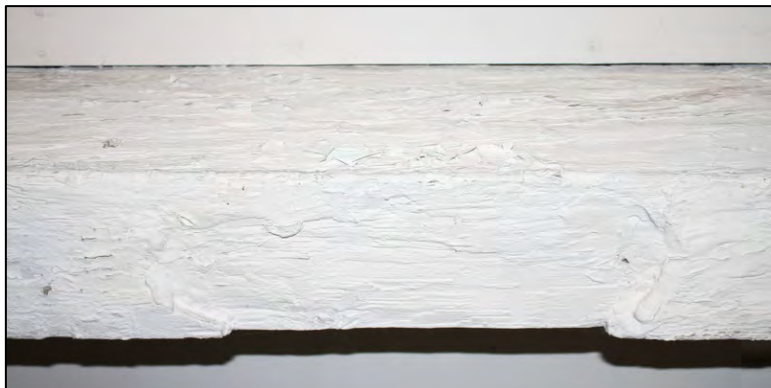
**Description:** A long cutaway in the soffit of the tie beam between Bays 4 and 5, in the southern part of the bay. It has rounded ends, and is typical of a column headplate scar,

possibly suggesting that there may have been an intention to replicate the two column rows seen on the floors below within the 5<sup>th</sup> floor.

**Assessment of Significance:** The feature appears to have been intended to house the headplate of a column, possibly suggesting an alternative original layout of the 5<sup>th</sup> floor, and is therefore considered to be of HIGH significance.

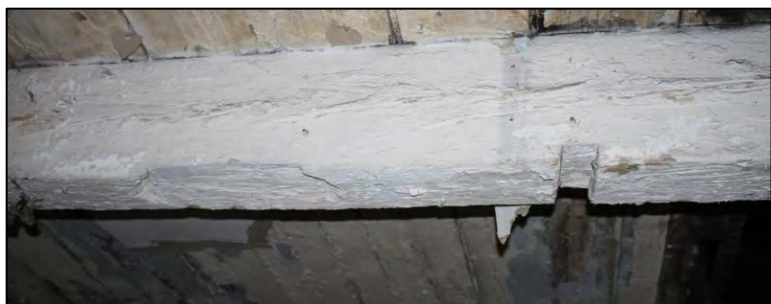
**Description:** A cutaway in the soffit of the tie beam between Bays 4 and 5, in the southern part of the bay. It is almost

square section, placed at a slight angle to the beam, and is of unclear function, but is heavily painted, suggesting that it is not a modern feature.

**Assessment of Significance:** The precise function of the cut-out is unknown, but it appears to be of relatively early date, but is considered to be of LOW significance.

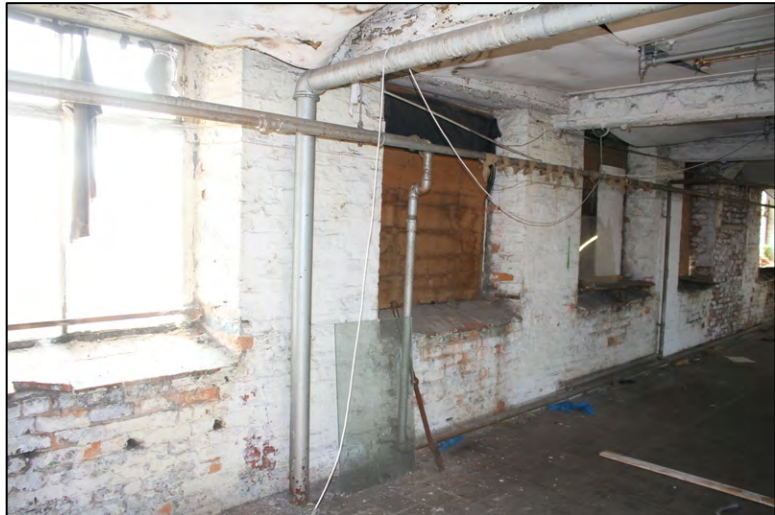
**Description:** Extant vertical riser in the sprinkler system, from the 4<sup>th</sup> floor into the main array within the 5<sup>th</sup> floor. It comprises a cast-iron water pipe, with an angle joint just below ceiling level translating the pipe adjacent to the west beam, where it feeds into the diminishing pipes throughout the floor.

**Assessment of Significance:** The sprinkler system represents a well-preserved example of early-twentieth century fire-fighting apparatus found within many mills. Although an important feature of the mill from its installation, which would have been contemporary with the external fire escape, it is unremarkable in its design, and it is therefore considered to be of MEDIUM significance. Its retention would hamper the programme of repair works being undertaken, and it has therefore been recorded as part of a laser scan of the entire floor level prior to its removal.

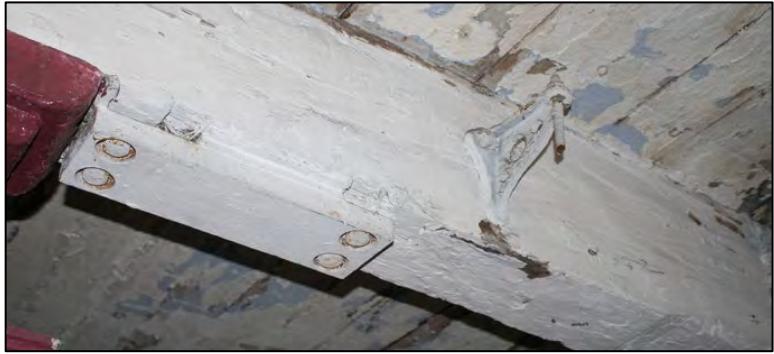
Feature Number: **5/39**

**Description:** Extant L-section bracket for sprinkler pipe, attached to the eastern face of ceiling beam between Bays 5 and 6, in the northern part of the bay.

**Assessment of Significance:** This, and a bracket to the south (**5/38**) has been retained following the removal of the remainder of the sprinkler system. As the only extant evidence of this important feature, it is considered to be of MEDIUM significance.

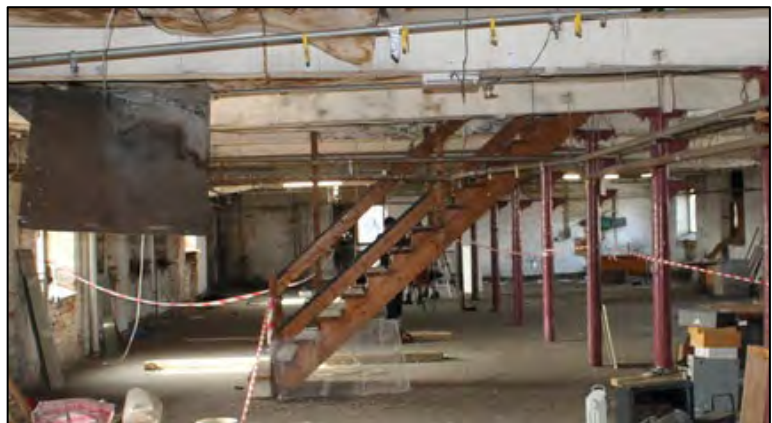
**Description:** A late timber straight stair from the 5<sup>th</sup> floor to the attic, inserted following the removal of part of the ceiling, almost certainly in the second half of the 20<sup>th</sup> century.

**Assessment of Significance:** The stair has no architectural value, and detracts from the open space of the 5<sup>th</sup> floor, and interpretation of access within the upper levels of the mill. It is considered to be of LOW significance.

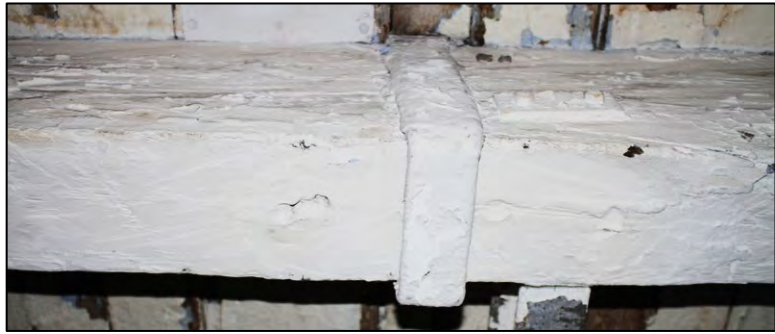
Feature Number: **5/42**

**Description:** A long shallow compression scar in the soffit of the tie beam between Bays 7 and 8, in the northern part of the bay. It has rounded ends, and is typical of a column headplate scar, possibly suggesting that there may have been an intention to replicate the two column rows seen on the floors below within the 5<sup>th</sup> floor. The scar is covered by the stirrup between the tie beam and queen post of the truss above, demonstrating that the stirrups were not features of the original trusses, but were added subsequently.

**Assessment of Significance:** The feature appears to have been intended to house the headplate of a column, possibly suggesting an alternative original layout of the 5<sup>th</sup> floor, and also demonstrates phasing within the extant truss assembly. It is therefore considered to be of HIGH significance.

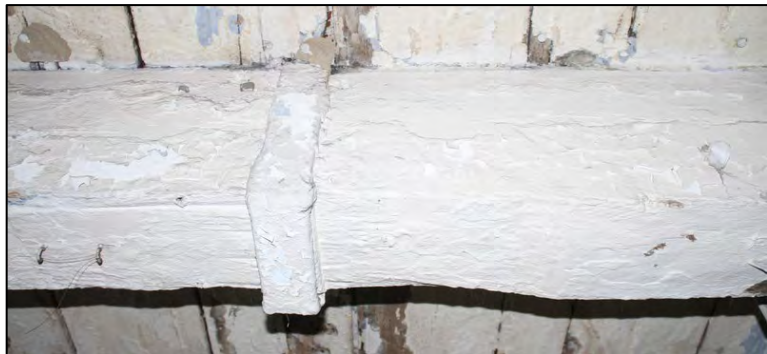
**Description:** A long shallow compression scar in the soffit of the tie beam between Bays 7 and 8, in the southern part of the bay. It has rounded ends, and is typical of a column headplate scar, possibly suggesting that there may have been an intention to replicate the two column rows seen on the floors below within the 5<sup>th</sup> floor. The scar is shallower than that to the north (**5/42**) but also covered by the stirrup between the tie beam and queen post of the truss above, demonstrating that the stirrups were not features of the original trusses, but were added subsequently.

**Assessment of Significance:** The feature appears to have been intended to house the headplate of a column, possibly suggesting an alternative original layout of the 5<sup>th</sup> floor, and also demonstrates phasing within the extant truss assembly. It is therefore considered to be of HIGH significance.

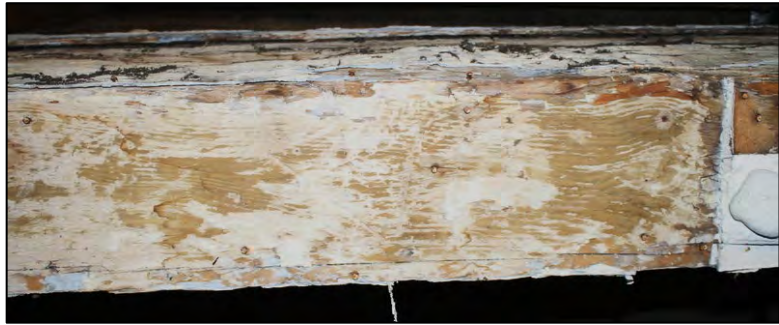
**Description:** A well-defined Baltic timber mark on the soffit of the ceiling beam between Bays 7 and 8, towards its northern end.

**Assessment of Significance:** The mark demonstrates that the timber is Baltic softwood, and is therefore considered to be of HIGH significance.

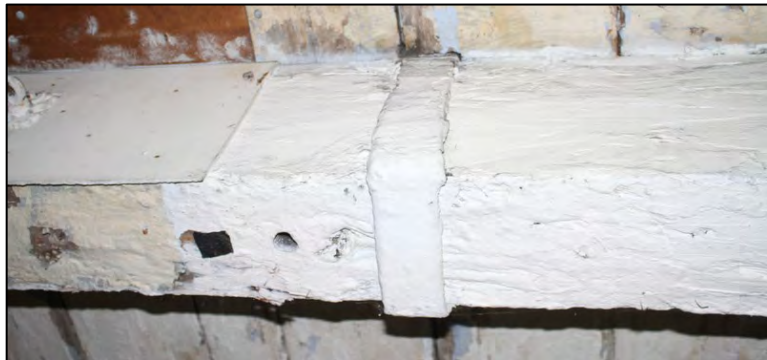
**Description:** A long shallow compression scar in the soffit of the tie beam between Bays 8 and 9, in the northern part of the bay, aligned with those in Bay 7.

It has rounded ends, and is typical of a column headplate scar, possibly suggesting that there may have been an intention to replicate the two column rows seen on the floors below within the 5<sup>th</sup> floor. The scar is shallower than that to the south (**5/46**) but also covered by the stirrup between the tie beam and queen post of the truss above, demonstrating that the stirrups were not features of the original trusses, but were added subsequently.

**Assessment of Significance:** The feature appears to have been intended to house the headplate of a column, possibly suggesting an alternative original layout of the 5<sup>th</sup> floor, and also demonstrates phasing within the extant truss assembly. It is therefore considered to be of HIGH significance.

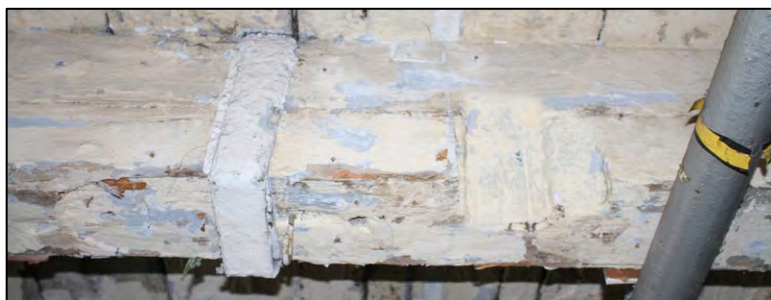
**Description:** A long shallow compression scar in the soffit of the tie beam between Bays 8 and 9, in the southern part of

the bay. It has rounded ends, and is typical of a column headplate scar, possibly suggesting that there may have been an intention to replicate the two column rows seen on the floors below within the 5<sup>th</sup> floor. The scar is deeper than that to the north (**5/45**) and clearly covered by the stirrup between the tie beam and queen post of the truss above, demonstrating that the stirrups were not features of the original trusses, but were added subsequently.

**Assessment of Significance:** The feature appears to have been intended to house the headplate of a column, possibly suggesting an alternative original layout of the 5<sup>th</sup> floor, and also demonstrates phasing within the extant truss assembly. It is therefore considered to be of HIGH significance.

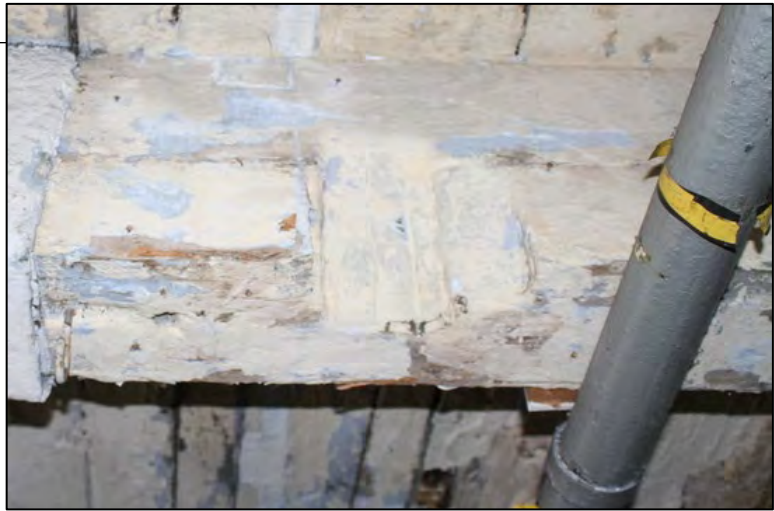
**Description:** A deep angled cutaway in the west face and soffit of the ceiling beam between Bays 8 and 9, in the southern part of the bay. The feature is deeper on its northern side, and is heavily painted, suggesting that it was relatively early, and possibly related to the power transfer system.

**Assessment of Significance:** The precise function of the cut-out is unknown, but it appears to be of relatively early date, and is considered to be of MEDIUM significance.

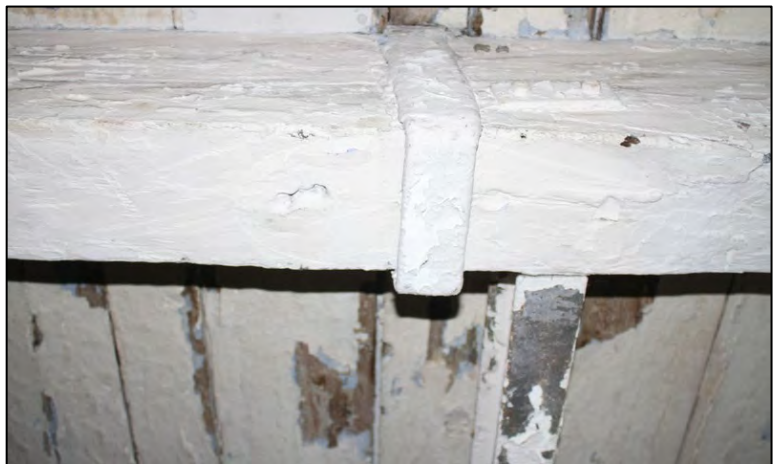
**Description:** An east/west aligned narrow I-section ceiling beam, placed across the northern part of the bay. The beam is fixed with square-headed bolts to either face at both ends.

The precise function of the beam is unknown, but it appears to be of relatively late date, and is therefore considered to be of LOW significance.

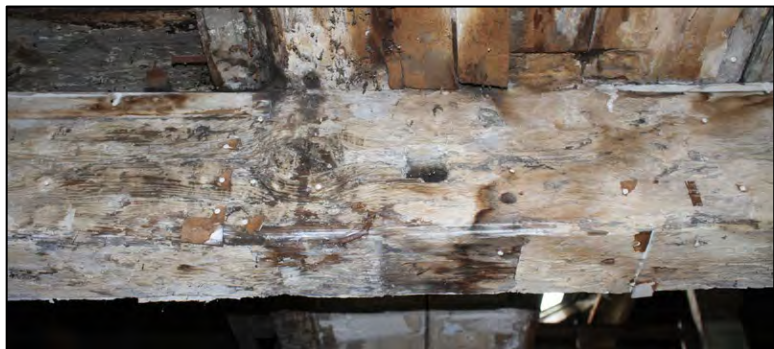
**Description:** A rectangular compression scar/cut-out in the soffit of the tie beam between Bays 7 and 8, in the southern

part of the bay. This does not have rounded ends, like others seen at this end of the mill, and has a square socket cut into the east face of the beam above.

**Assessment of Significance:** The precise function of the compression mark or possibly associated cut-out on the beam face is unknown, and is of unclear date. It is therefore considered to be of MEDIUM significance.

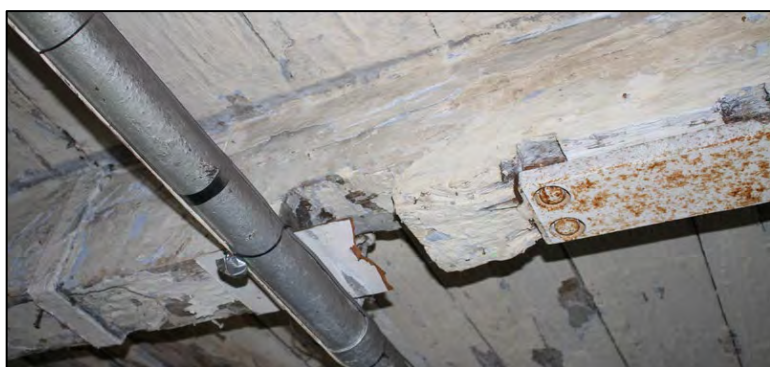
Feature Number: **5/51**

**Description:** A deep, rounded cutaway in the soffit of the tie beam between Bays 8 and 9, in the southern part of the bay. Similar in size and style to a further cutaway in the same beam to the north (**5/52**).

**Assessment of Significance:** The precise function of the cut-out is unknown, but similar features observed in earlier mills would normally be associated with the power transfer system. It appears to be of relatively early, or possibly original date, and is therefore considered to be of HIGH significance.

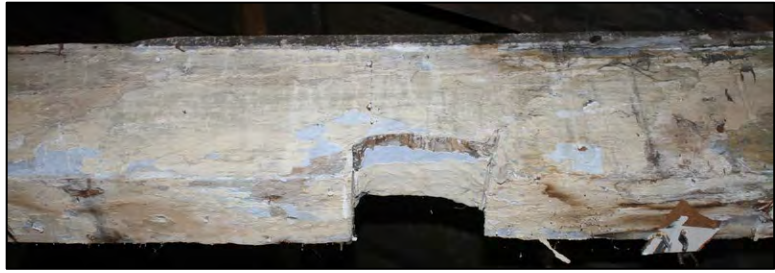
**Description:** A deep, rounded cutaway in the soffit of the tie beam between Bays 8 and 9, in the northern part of the bay. Similar to that to the south (**5/51**) and overlain by hanger for sprinkler system, showing it to have been redundant by the early-20<sup>th</sup> century.

**Assessment of Significance:** The precise function of the cut-out is unknown, but similar features observed in earlier mills would normally be associated with the power transfer system. It appears to be of relatively early, or possibly original date, and is therefore considered to be of HIGH significance.

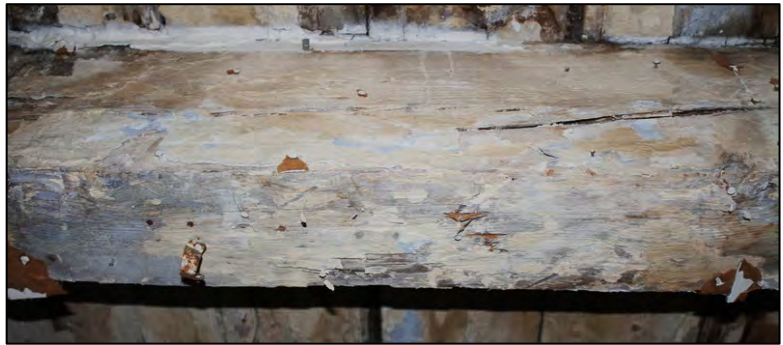
**Description:** A Baltic timber mark on the soffit of the ceiling beam between Bays 8 and 9, to the south of the central column.

**Assessment of Significance:** The mark demonstrates that the timber is Baltic softwood, and is therefore considered to be of HIGH significance.

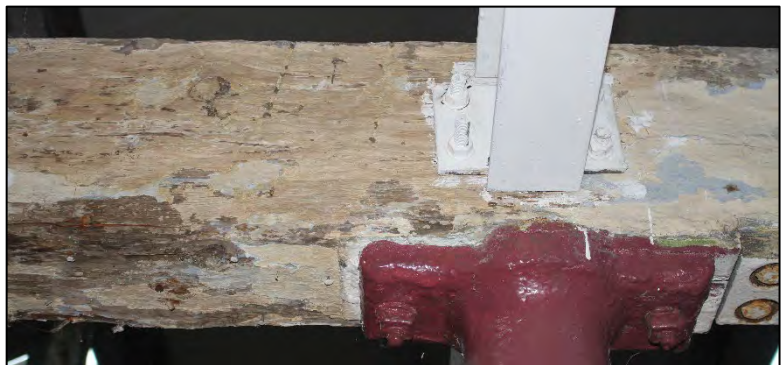
**Description:** A Baltic timber mark on the east face of the ceiling beam between Bays 8 and 9, immediately above central column.

The mark demonstrates that the timber is Baltic softwood, and is therefore considered to be of HIGH significance.

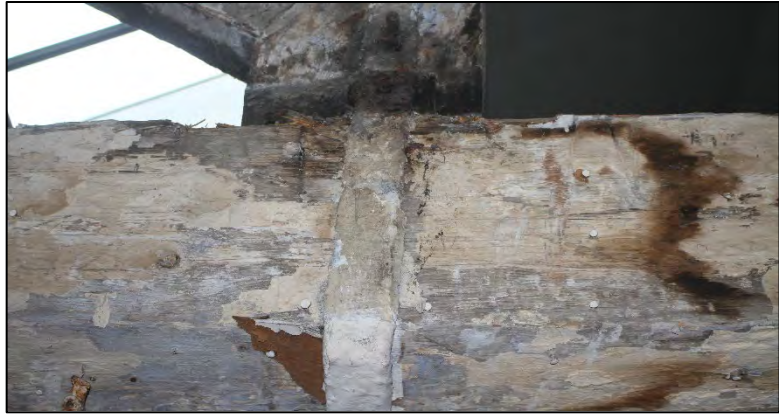
**Description:** A Baltic timber mark on the east face of the ceiling beam between Bays 8 and 9, immediately below the southern principal rafter of the truss above (**6/01**).

The mark demonstrates that the timber is Baltic softwood, and is therefore considered to be of HIGH significance.

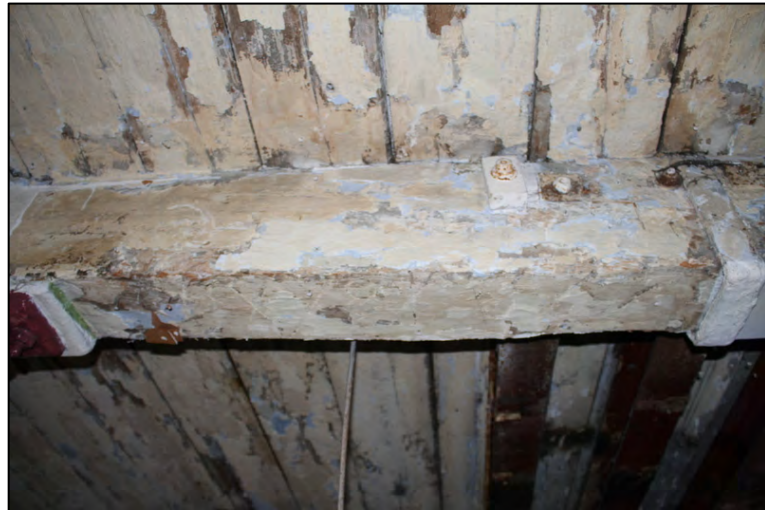
**Description:** A well-defined Baltic timber mark on the soffit of the ceiling beam between Bays 9 and 10, to the south of the central column.

The mark demonstrates that the timber is Baltic softwood, and is therefore considered to be of HIGH significance.

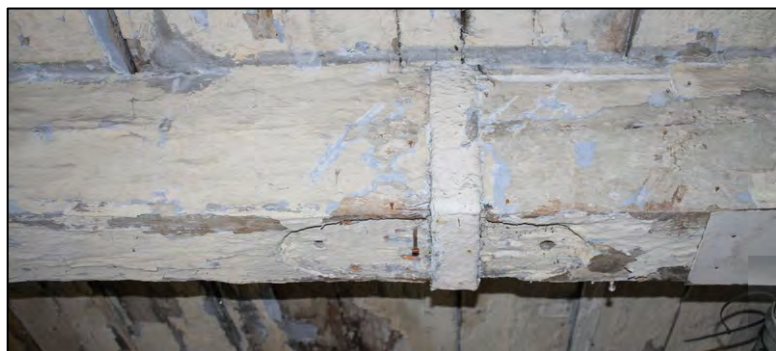
**Description:** A long shallow compression scar in the soffit of the tie beam between Bays 9 and 10, in the northern part of the bay. It has rounded ends, and is typical of a column headplate scar, possibly suggesting that there may have been an intention to replicate the two column rows seen on the floors below within the 5<sup>th</sup> floor. The scar is clearly covered by the stirrup between the tie beam and queen post of the truss above, demonstrating that the stirrups were not features of the original trusses, but were added subsequently.

**Assessment of Significance:** The feature appears to have been intended to house the headplate of a column, possibly suggesting an alternative original layout of the 5<sup>th</sup> floor, and

also demonstrates phasing within the extant truss assembly. It is therefore considered to be of HIGH significance.

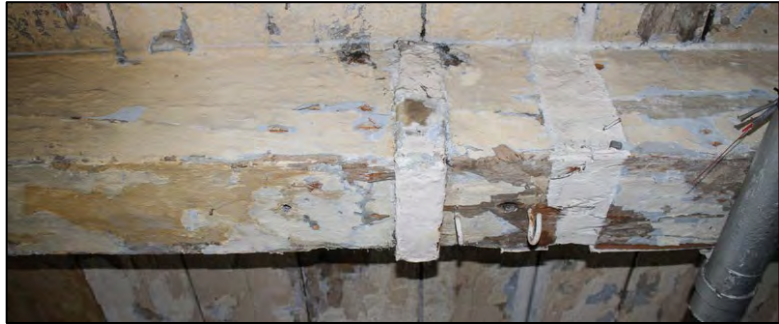
**Description:** A long shallow compression scar in the soffit of the tie beam between Bays 10 and 11, in the northern part of the bay. It has rounded ends, and is typical of a column headplate scar, possibly suggesting that there may have been an intention to replicate the two column rows seen on the floors below within the 5<sup>th</sup> floor. The scar is clearly covered by the stirrup between the tie beam and queen post of the truss above, demonstrating that the stirrups were not features of the original trusses, but were added subsequently.

**Assessment of Significance:** The feature appears to have been intended to house the headplate of a column, possibly suggesting an alternative original layout of the 5<sup>th</sup> floor, and also demonstrates phasing within the extant truss assembly. It is therefore considered to be of HIGH significance.

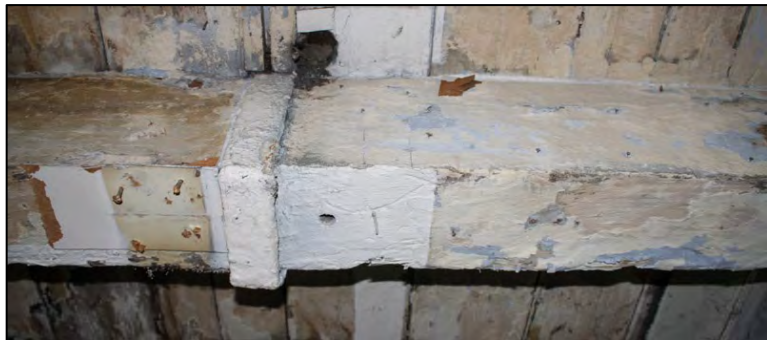
**Description:** An approximately square cut-out in the east face of the tie beam between Bays 9 and 10, at the northern end of the bay. It has a rounded head, possibly relating to the shape of a bolt that it housed, but is of unclear function.

**Assessment of Significance:** The precise function of the cut-out is unknown, but it appears to be of relatively early date, and is considered to be of MEDIUM significance.

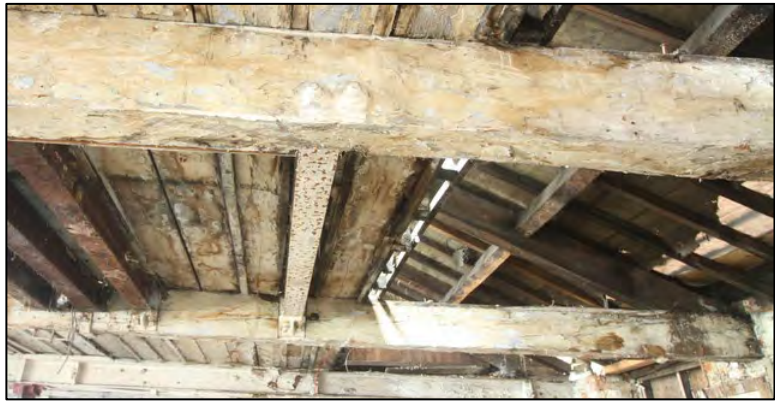
**Description:** An east/west aligned steel I-section ceiling beam, placed across the southern part of the bay, and carried on a cast-iron L-section bracket on the inner face of both tie beams. The beam

probably replaced an earlier timber example. Appears to be associated with a bearing box above the window in the south wall (**5/62**) and with three similar beams to the north (**5/61**).

**Assessment of Significance:** The beam appears to be associated with a bearing box in the south wall, and possibly represents the remodelling of an earlier beam in this position, , and is therefore considered to be of MEDIUM significance.

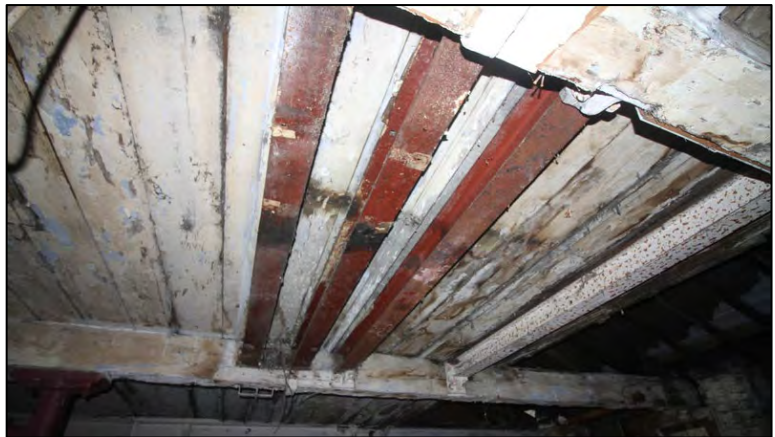
**Description:** Three east/west aligned steel I-section ceiling beams, placed across the southern part of the bay. All appear contemporary, and probably later than beam **5/60** to the south, although the southern of the three beams, is

similarly carried on a cast-iron L-section bracket on the inner face of both tie beams. It is unclear whether the beams are associated with a bearing box above the window in the south wall (**5/62**) and with beam **5/60** to the south.

**Assessment of Significance:** The beams are possibly associated with a bearing box in the south wall, but represent late remodelling, and are therefore considered to be of LOW significance.

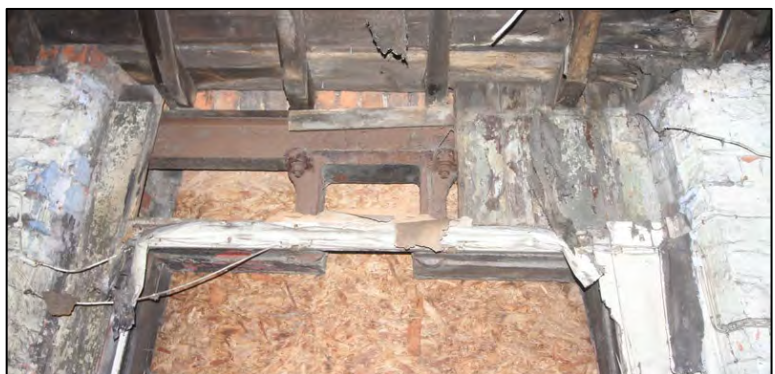
**Description:** Bearing box suspended from an I-section steel beam above the window in the south wall of Bay 10. It is open on its lower side, where the transom of the window has

also been cut to accommodate the feature, which probably housed a rail for an external hoist

that appears to have been inserted into the window aperture, and may have been replaced by the later tower constructed to the south of Bay 7.

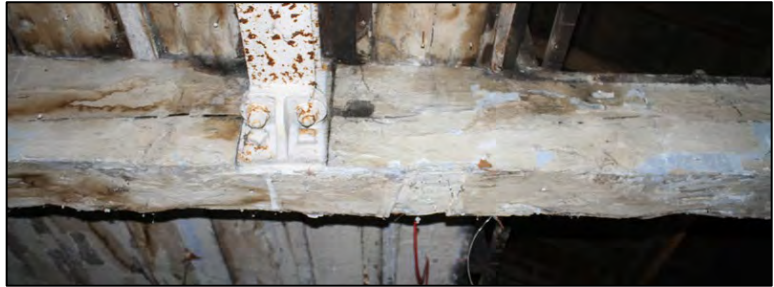
**Description:** A cutaway in the soffit of the tie beam between Bays 10 and 11, in the southern part of the bay. It is almost square section, placed at a slight angle to the beam, and is of unclear function, but is heavily painted, suggesting that it is not a modern feature.

**Assessment of Significance:** The precise function of the cut-out is unknown, but it appears to be of relatively early date, and is considered to be of MEDIUM significance.

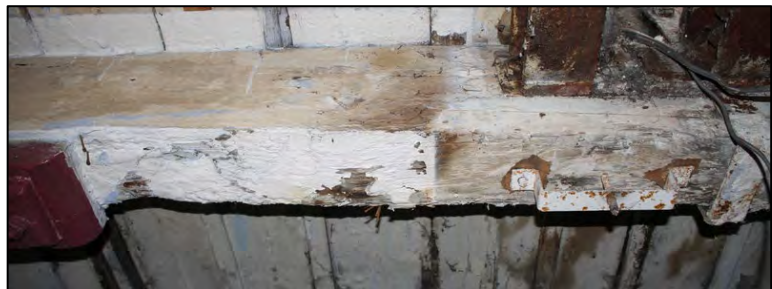
**Description:** A Baltic timber mark on the soffit of the ceiling beam between Bays 10 and 11, in the southern part of the bay.

**Assessment of Significance:** The mark demonstrates that the timber is Baltic softwood, and is therefore considered to be of HIGH significance.
