**SALFORD  
ARCHAEOLOGY**

## **Gazetteer of Features of Heritage Significance**

5<sup>th</sup> & 6<sup>th</sup> Floors,  
Islington Mill, Salford

# *Islington Mill Gazetteer of Features of Heritage Significance*

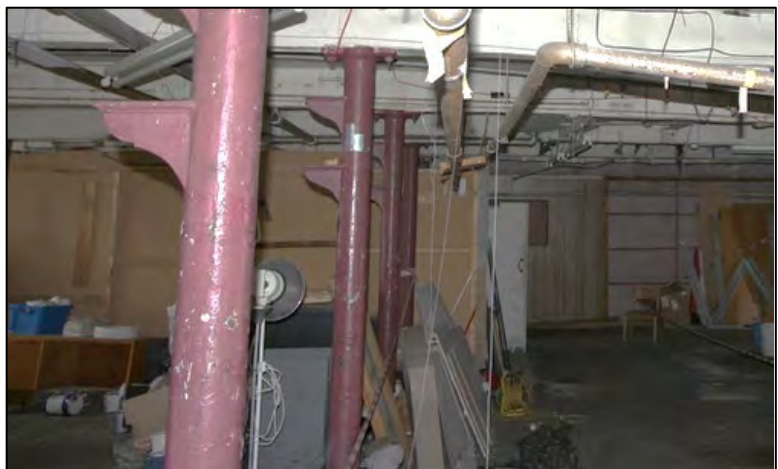
The low-quality construction wall detracted from the open space of the 5<sup>th</sup> floor, and is therefore considered to be of LOW significance, but was recorded prior to its removal.

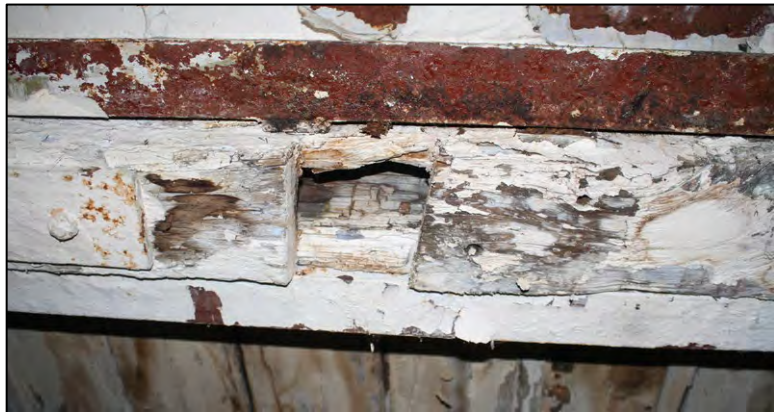
**Description:** A deep, rectangular cutaway in the soffit of the tie beam between Bays 11 and 12, in the southern part of the bay. The aperture is blocked to either side by late flitch plates (**5/66**), and potentially relates to the earlier power transmission system within the 5<sup>th</sup> floor.

**Assessment of Significance:** The precise function of the cut-out is unknown, but similar features observed in earlier mills would normally be associated with the power transfer system. It appears to be of relatively early, or possibly original date, and is therefore considered to be of HIGH significance.

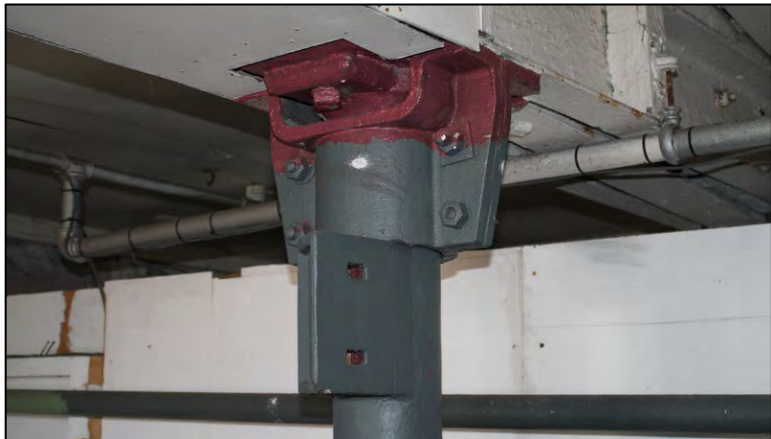
**Description:** A collar placed around the head of the eastern original collar to carry the channel-section flitch plates to the eastern beam (**5/66**). It rests on the vertical casting for the end bearing mounting of the original column.

**Assessment of Significance:** This represents 20<sup>th</sup> century strengthening of the eastern tie beam, but detracts from the form of the highly unusual eastern column, possibly causing stress to the vertical casting for the end bearing of the original line shaft. It is therefore considered to be of LOW significance.

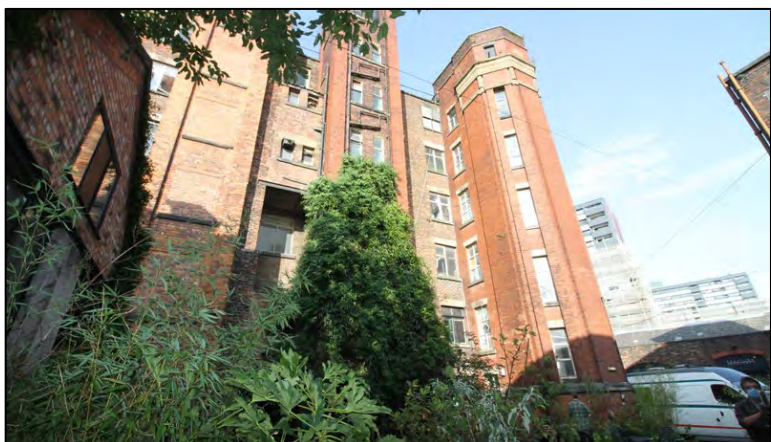
**Description:** Machine-made red brick external stair tower added to the eastern end of the south wall of Islington Mill. Added in the early-20<sup>th</sup> century, possibly replacing a stair tower that encased the original chimney, to the south of the power plant in Bay 3.

**Assessment of Significance:** Although a relatively late feature, the tower forms good visual evidence for the development of the mill complex around the turn of the 20<sup>th</sup> century, and is considered to be of MEDIUM significance.

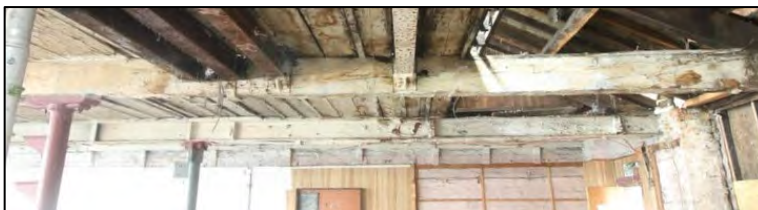
**Description:** Six tiered brick corbels of four courses height

placed from the southern end of the east gable wall to the position of the northern eaves partition in the attic above. Together they support a small ceiling beam (**5/72**) that carried the eastern end of the ceiling planks of Bay 12.

**Assessment of Significance:** Although only marginally decorative, the corbels provide good evidence of the original construction of the mill, and in particular the method of carrying the large planks forming the attic floor from the gable wall to the eastern truss. They are therefore considered to be of HIGH significance.

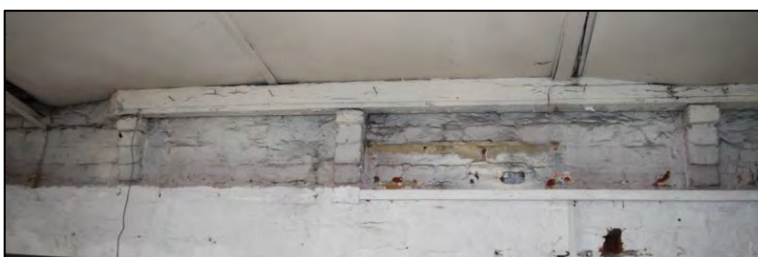
**Description:** A three-piece timber rail placed on tiered corbels **5/71** to carry the eastern end of the ceiling planks of Bay 12.

The northern end of the beam is chamfered to the wall face, providing slight architectural detailing, but the members are joined with a simple scarf joint, and a butt joint, the latter possibly representing the attachment of a replaced member.

**Assessment of Significance:** Although only marginally decorative, the beam provides good evidence of the original construction of the mill, and in particular the method of carrying the large planks forming the attic floor from the gable wall to the eastern truss. It is therefore considered to be of HIGH significance.

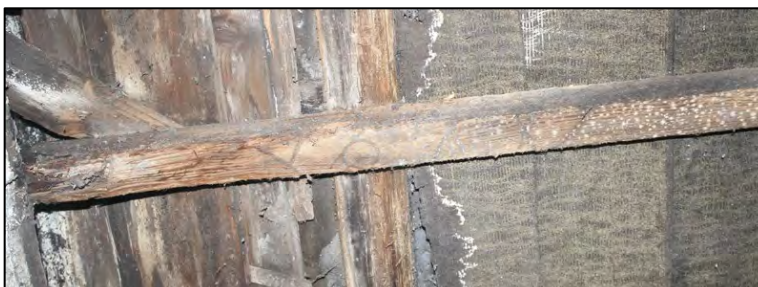
**Description:** A Baltic timber mark on the soffit of a rafter in the lower part of the north pitch of Bay 12. This provides good evidence that many of the rafters are original

**Assessment of Significance:** The mark demonstrates that the timber is early, and of Baltic softwood, and is considered to be of MEDIUM significance.

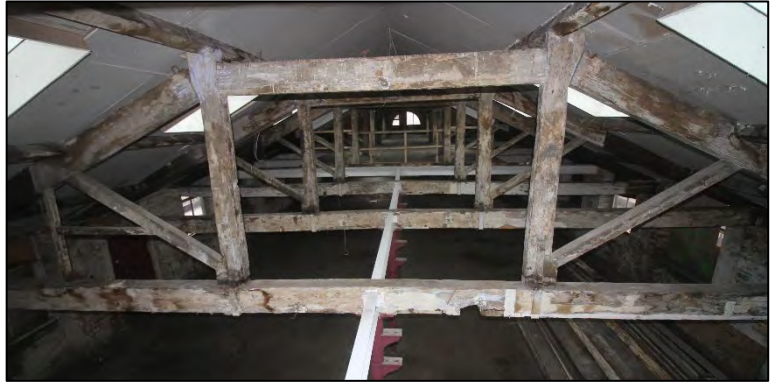
**Description:** Each bay division is spanned by a timber queen post truss, the tie beam of which formed the ceiling beams of the 5<sup>th</sup> floor below (**5/03**). Both queen posts are of relatively large scantling rectangular section, tenoned into the tie beam below floor level, with the joint apparently having been augmented subsequently with an iron stirrup. The jowled outer part of the foot of each queen post supports a slender straight brace to the principal rafter, itself tenoned into the jowled head of the queen post, that clasps the upper of three purlins to each pitch. Straining beams complete the truss, placed level with the head of each principal rafter.

large scantling rectangular section, tenoned into the tie beam below floor level, with the joint apparently having been augmented subsequently with an iron stirrup. The jowled outer part of the foot of each queen post supports a slender straight brace to the principal rafter, itself tenoned into the jowled head of the queen post, that clasps the upper of three purlins to each pitch. Straining beams complete the truss, placed level with the head of each principal rafter.

**Assessment of Significance:** The trusses are original to the construction of the mill, and thus an integral element of the structure and are of HIGH significance.

Several of the timbers are in poor condition, and their repair has been included within the current project. These will be undertaken sympathetically, retaining as much original fabric as possible, whilst attempting not to obscure any significant detail. Cleaning of the timbers will be undertaken carefully to avoid damage to features identified on the beams. Three of the straining beams will be removed to facilitate improved access and usage of the roof space. Their loss has been mitigated by a 3D laser scan of the attic accompanied by photographs and descriptions.

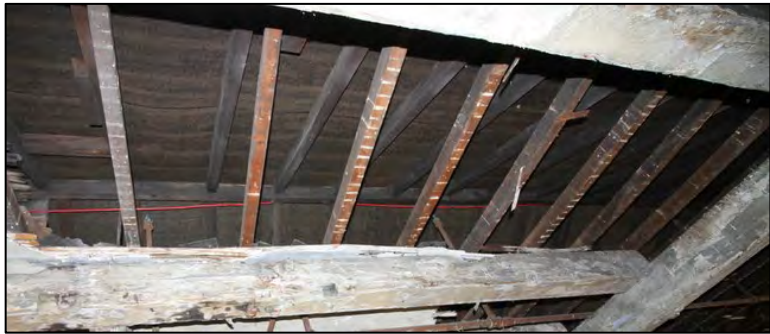
**Description:** Somewhat unusually for a queen post truss roof, the structure has a ridge purlin, comprising an edge-set timber board, typical of roof structures from the second half of the 19<sup>th</sup> century and more commonly associated with king post trusses. They appear to be butt-ended along the length of the roof, and form part of a renewal of the roof, that was probably associated with the addition of towers to the southern elevation of the mill in the early 20<sup>th</sup> century.

**Assessment of Significance:** The ridge boards form part of a renewal of the roof structure, probably in the early 20<sup>th</sup> century, and are of LOW significance.

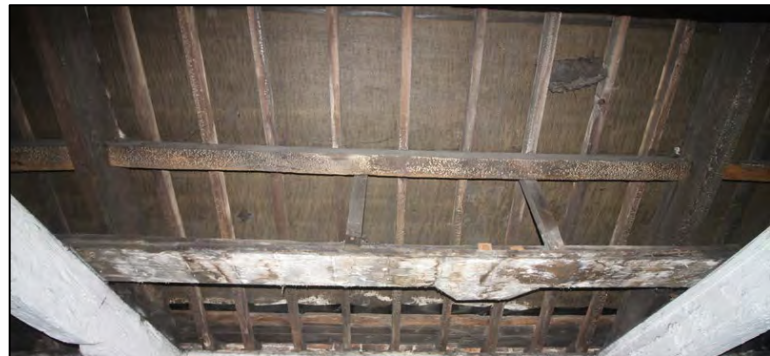
**Description:** The majority of the rafters appear to form part of the renewal of the roof associated with the ridge purlins (**6/03**). They are circular sawn rectangular section, and of typical late 19<sup>th</sup> century or later style. A Baltic timber mark observed on the foot of one rafter (**5/71**) suggests that all are of imported European softwood. Similar-section timbers were also added as collars to most rafter pairs from Bay 3 eastwards, for the insertion of a suspended ceiling, almost certainly undertaken at the same time.

**Assessment of Significance:** The majority of the rafters form part of a renewal of the roof structure, probably in the early 20<sup>th</sup> century, and are of LOW significance. Earlier rafters have been highlighted as separate entries within this gazetteer

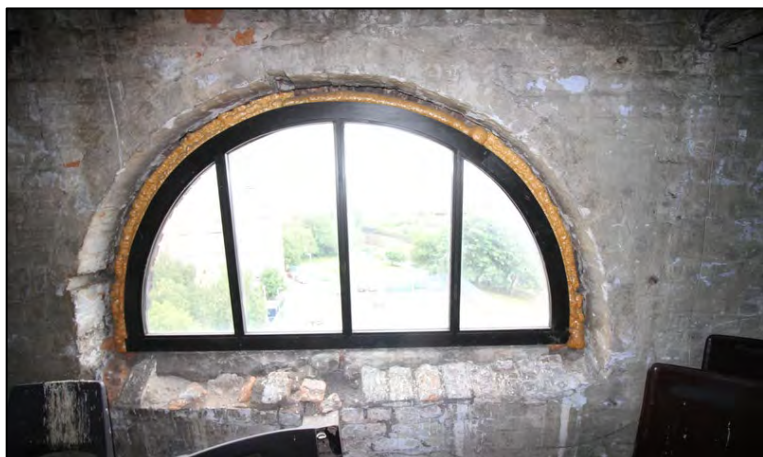
**Description:** Either end of the mill has a vertical gable wall that forms a continuation of the hand-made brick end walls of the floor below (**5/01**). Both are heavily painted, obscuring detail, but are dominated by central, large round-headed

windows (6/06).

**Assessment of Significance:** The walls form an integral element of the structure and are of HIGH significance. Interventions should ideally be kept to a minimum to preserve this important original fabric.

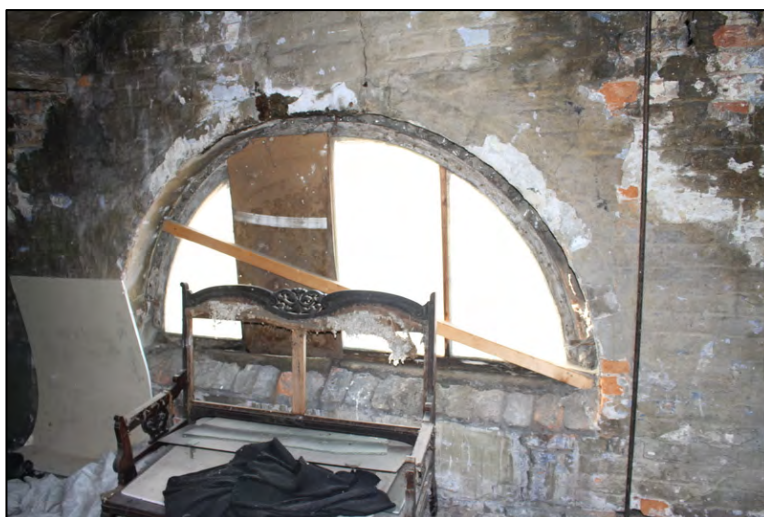
**Description:** Both gable walls (6/05) house large central round headed windows. Both have replacement window frames of differing late age, but the apertures remain unaltered with the round-headed arch formed by a single course of edge-set brick, and a sloping sill of angled brick.

**Assessment of Significance:** The window apertures form an integral element of the structure and are of HIGH significance. Interventions should ideally be kept to a minimum to preserve this important original fabric. The frames and glazing are of little heritage merit.

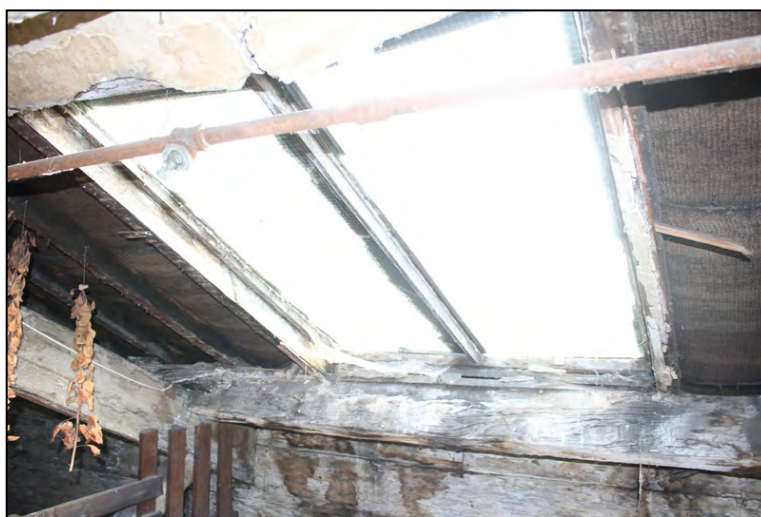
**Description:** Skylight windows in the both pitches of the roof, in alternating bays, and alternating per pitch, to provide a skylight to each bay apart from that eastern bay, where the stair tower was inserted in 1928. They were placed centrally within each bay, spanning the whole space between the upper

and central purlins and are typically of timber-framed construction, with narrow surround and glazing bar between the two vertical panes of later reinforced mesh glass.

That in Bay 3, within the north pitch, is a three-light window, possibly representing the more original form, prior to later reglazing, whilst those in Bays 1, 7, and 11 had more recent Velux-type double-glazed, single light replacements.

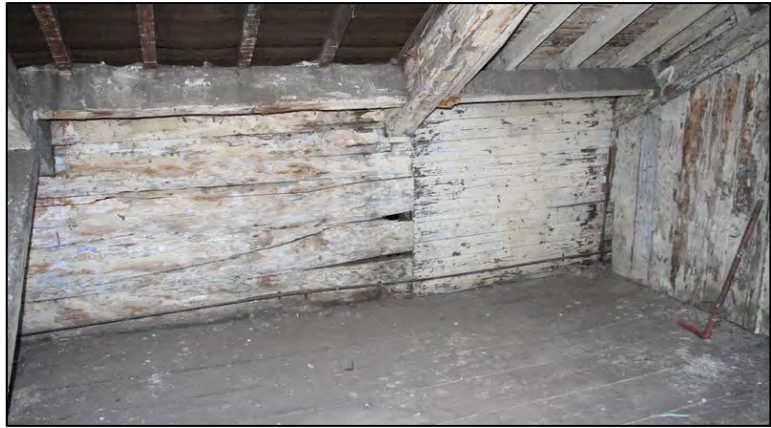
**Description:** The southern eaves of the attic were partitioned at a similar location to those on the northern side of the roof space (**6/09**) but comprised horizontal timber planks of various sizes. This probably represents a later remodelling of the roof space either enclosing previously open eaves, or replacing damaged lath and plaster. However, it would appear to be a relatively early intervention given the similarity with the white and Dolly Blue paint layers also observed on the original roof trusses (**6/01**) and purlins (**6/02**). The eastern two bays of the northern eaves also retained planked rather than plaster eaves partitions.

**Assessment of Significance:** The timber planked southern eaves partitions appear to represent an unusual remodelling of the eaves partition, and are considered to be of MEDIUM significance. However, given the poor preservation of the roof timbers, and planking to the eaves floor, both eaves partitions must be removed. Their loss has been mitigated by 3D laser scanning and photographic recording.

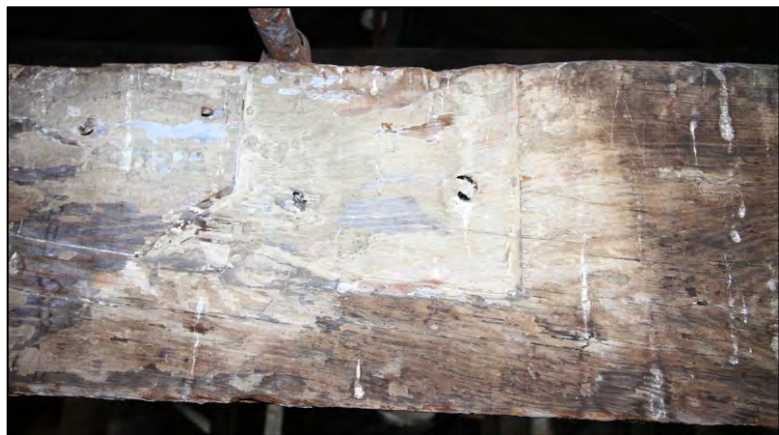
**Description:** The majority of the original roof trusses (**6/01**) have compression marks on the eastern face of the straining beam. This denotes the position of the mounting brackets for pillow bearings

that were placed on top of each straining beam, carrying a line shaft down the length of the attic, in both directions from the upright shaft in Bay 3. That between Bays 1 and 2 also has a rounded cut out (**6/12**), possibly suggesting that the original intention had been to socket the bearing into the straining beam, rather than on a raised pillow bracket.

**Assessment of Significance:** The compression marks provide evidence for the original power transfer system within Islington Mill, and demonstrate that power was used in the upper floor. They are therefore considered to be of HIGH significance and damage should be avoided when cleaning the trusses.

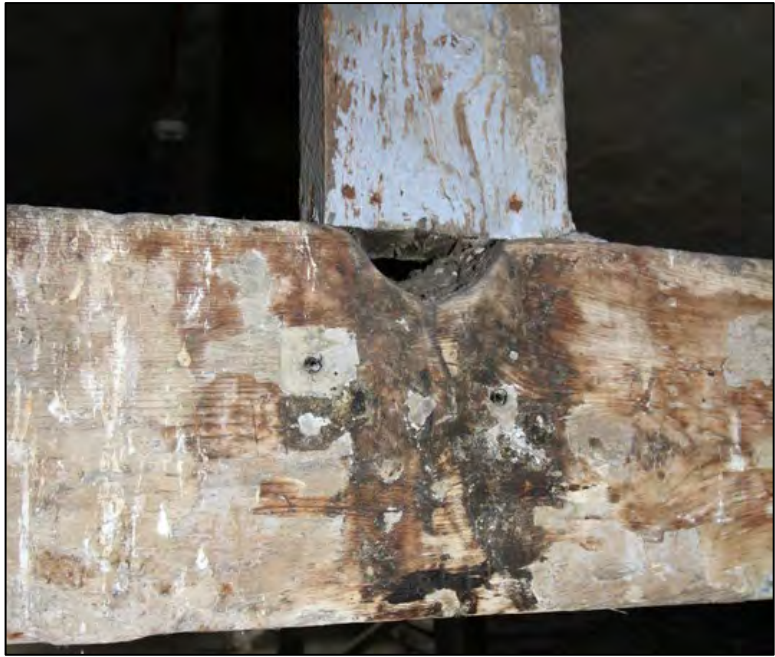
**Description:** Rounded cut out in the straining beam of the truss between Bays 1 and 2. This possibly suggests that the original intention had been to socket the bearing into the straining beam, rather than on a raised pillow bracket. The beam has a compression mark below on its eastern face, with green staining from a brass bearing bracket, demonstrating that a similar bracket was installed, similar to the trusses to the east of the upright shaft. The cutaway is blocked by a king post inserted above the straining beam (**6/13**).

**Assessment of Significance:** The combined cut out and compression mark provide evidence for the original power transfer system, and a possible modification to the original design within the upper floor of Islington Mill. It is, therefore considered to be of HIGH significance and damage should be avoided when cleaning the trusses.

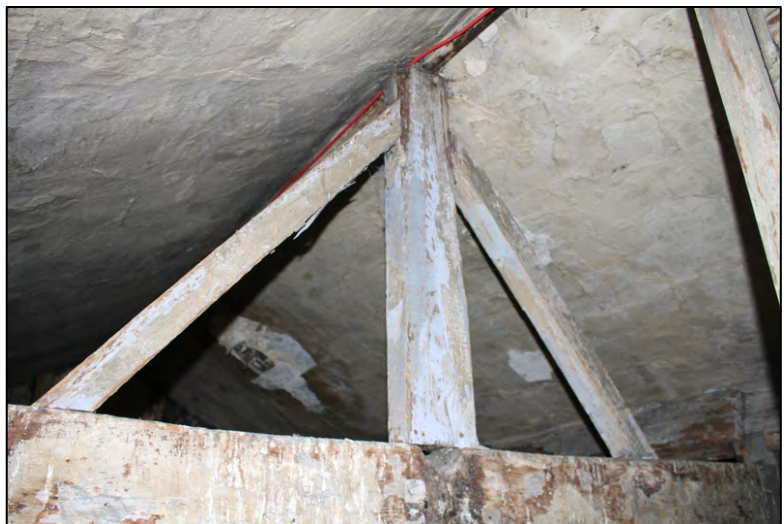
**Description:** A slender king post and angled braces was added to the western face of the truss between Bays 1 and 2 above the straining beam. The king post clasps the slender ridge board (**6/03**), and is probably of contemporary date. It blocks the position of the line shaft bearing (**6/11** and **6/12**) at the western end of the mill, demonstrating that line shafting was no longer required, at least in the western end of the attic, by this date.

**Assessment of Significance:** The additional truss members appear to relate to the remodelling of the roof in the early-20<sup>th</sup> century, and may denote its western extent, given the survival of plaster undersealing to the west (**6/14**). It is therefore considered to be of MEDIUM significance.

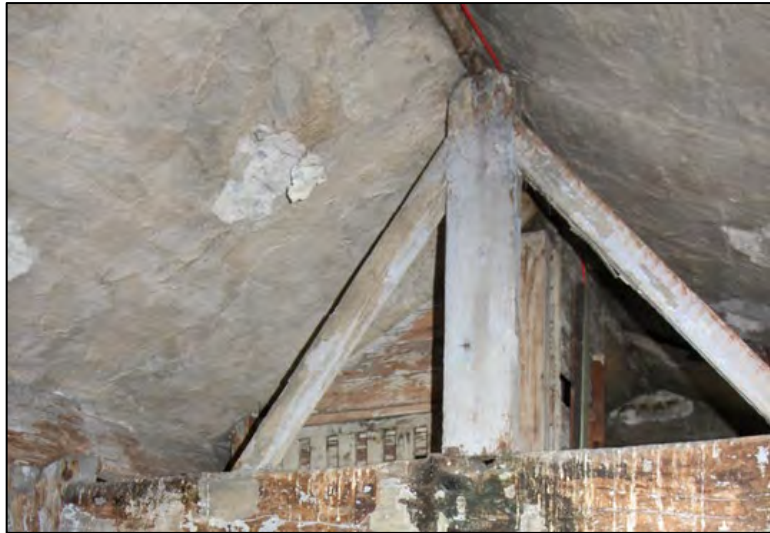
**Description:** The western two bays of the attic retain a lath and plaster ceiling, undersealing the rafters. This comprises similar horse-hair and lime-based fabric to the plastered eaves partition (**6/08**), laid over close-set laths, and is likely to represent the original form of the ceiling throughout the attic. It is bounded on its eastern side by additional support for the ridge board (**6/13**), possibly suggesting that the roof below the plaster retains its original layout.

**Assessment of Significance:** The small remnant of plastered ceiling appears to represent the original form of the attic, also possibly suggesting that less significant remodelling of the roof was undertaken to the western end of the roof in the early-20<sup>th</sup> century. It is therefore considered to be of HIGH significance. However, given the poor preservation of the roof timbers, and the structural failure of the roof as a whole, the ceiling has to be removed during the current phase of repair works. Its loss has been mitigated by 3D laser scanning and photographic recording.

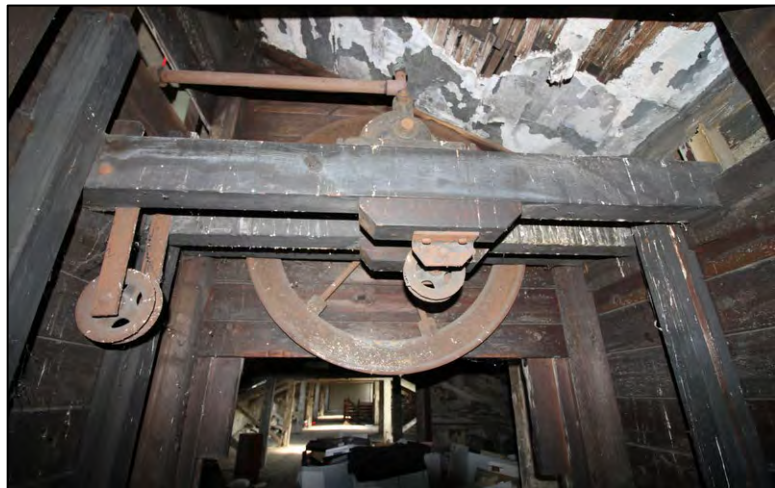
**Description:** A hoist between the 5<sup>th</sup> and 6<sup>th</sup> floors, placed in the southern part of the western bay. It survives to the full height of the bay, and comprises horizontal tongue-and-grooved planking to a squared timber stud frame. An opening in the west side may have had a door at some point, and affords access into the hoist tower, which retains timber framing carrying a large pulley wheel, and two smaller pulley wheels for a rope on the western side. The aperture between floors (**5/14**) also has an *in-situ* cover.

**Assessment of Significance:** The feature represents an insertion, probably in the late-19<sup>th</sup> or early 20<sup>th</sup>-century, although the housing may be for an earlier opening between the two floors. The hoist mechanism survives intact, increasing its rarity, and it is therefore considered to be of HIGH significance.

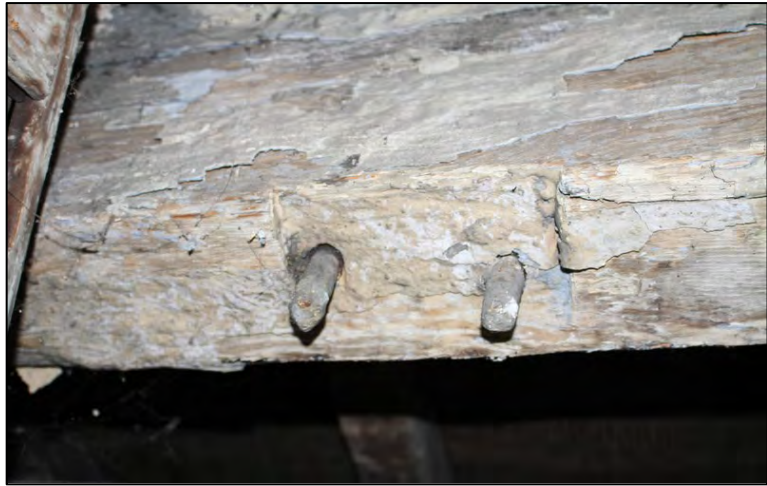
**Description:** A pair of threaded iron bolts project from the soffit of the upper purlin of the south pitch of the roof in Bay 1. They are placed within a rectangular compression mark, and clearly represent the mounting for a bracket.

Whilst the precise purpose of the bracket is unclear, it is likely to relate to either an end bearing for the line shafting at the western end of the attic, or to the adjacent hoist (**6/15**), possibly representing the remains of an earlier hoist in this position that was powered by the line shafting.

**Assessment of Significance:** The bolts relate to a bracket or bearing that appears early, and probably original to the use of the attic within the mill, and it is therefore considered to be of HIGH significance.

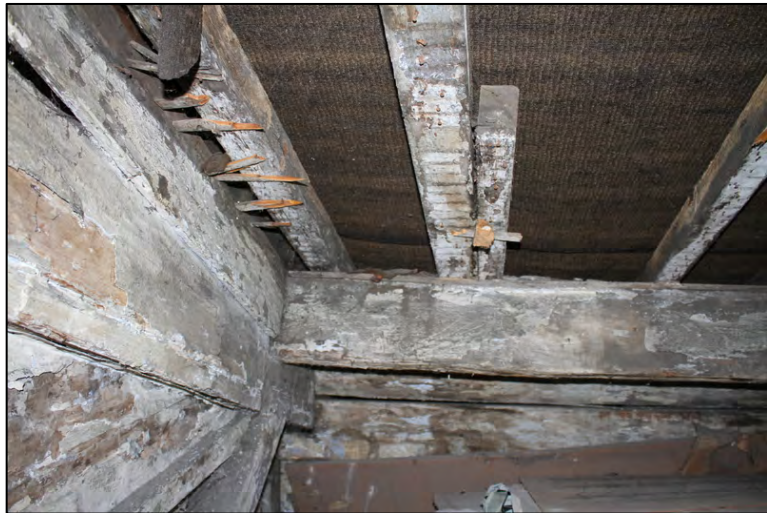
**Description:** A pair of larger scantling rafters on the southern pitch of Bay 2, compared with the majority of late rafters (**6/04**). These were placed adjacent to the truss between Bays 2 and 3, and were placed on their flat section of approximately 4", rather than being edge-set, like the replacement 2-3" rafters.

**Assessment of Significance:** The rafters appear to have been part of the original roof structure, but it is unclear whether they survive in their original position, or were simply re-used during the refurbishment of the roof. However, they are considered to be of HIGH significance, and should be retained during the roof repairs if practical. However, should this prove unfeasible, their loss has been mitigated by 3D laser scanning and photographic recording.

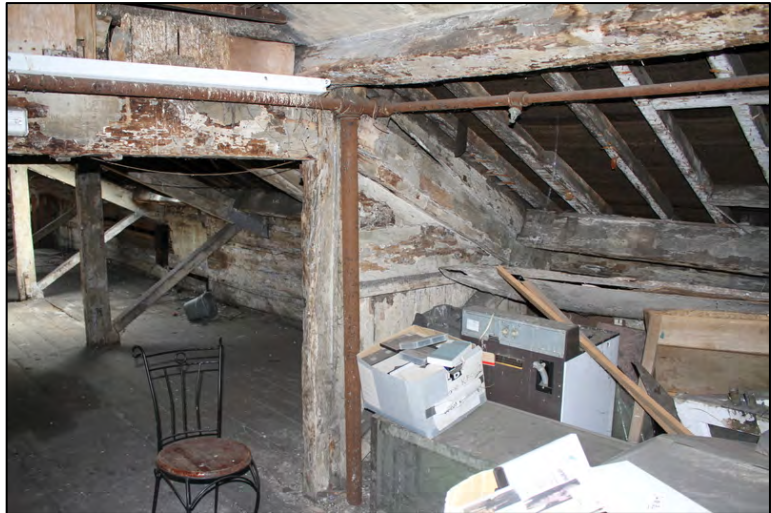
**Description:** the vertical riser for the supply of the sprinkler system to the attic was placed within Bay 2, adjacent to the south queen post on the eastern side of the bay, to minimise impact on movement throughout the attic. It is of smaller section than on the floors below, and has a T-piece

at its head feeding diminishing-section pipes throughout the attic. That providing the feed to the east blocks the line shaft position, demonstrating that this had become redundant by the time that the sprinkler system was installed.

**Assessment of Significance:** The sprinkler system was extant within the roof space at the time of the initial inspection of the mill, and represents a fine example of early-20<sup>th</sup> century fire-fighting improvements within a mill setting. Although an important feature of the mill from its installation, which would have been contemporary with the external fire escape, it is unremarkable in its design, and it is therefore considered to be of MEDIUM significance. Its retention would hamper the programme of repair works being undertaken, and it has therefore been recorded as part of a 3D laser scan of the entire floor level prior to its removal.

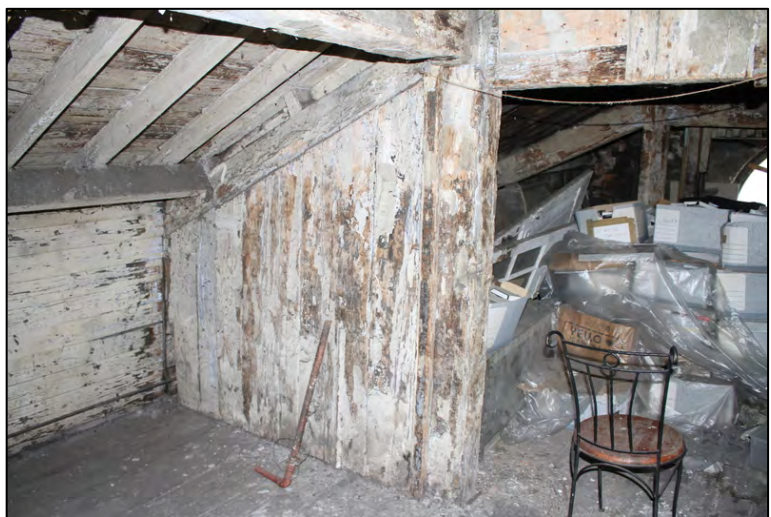
**Description:** The eastern face of the truss between Bays 2 and 3 has a partial partition wall formed of vertically-set timber planks. This survived from both queen posts to the eaves partition walls (**6/09** and **6/10**), and in part, above the straining beam. The boarding to the southern queen post stopped

slightly short of its inner edge. Where two iron pintels survive, clearly representing the hanging for door hinges. This would have had to have either been only a partial door across the opening between the queen posts, or a folding door, in order to allow it to pass the upright shaft (**6/20**), that as placed in the western part of Bay 3. The fabric and condition of the partition suggests that it represents an original feature within the roof space, rather than post-dating the use of the upright shaft, although it may represent an early addition following the apparent repositioning of the upright shaft (**6/21**).

**Assessment of Significance:** The partition represents an early, probably original feature, providing detail of the early use of the attic space, and is considered to be of HIGH significance, and should be retained during the roof.

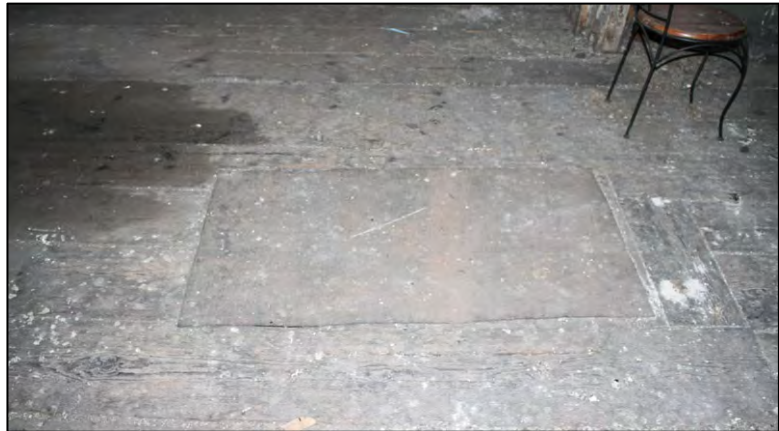
**Description:** Metal plate covering for the upright shaft from the 5<sup>th</sup> floor (**5/25**). This would have been added following the replacement of the shaft, which appears to have happened in the mid-19<sup>th</sup> century.

**Assessment of Significance:** Whilst the metal plate signifies the redundancy of the original power transmission system, it is probably of relatively early date, and is therefore considered to be of MEDIUM significance. It's retention is not critical to the future visual interpretation of the attic space, so long as the aperture it covers is not concealed without evidence for its position, for example, by a continuous floor covering.

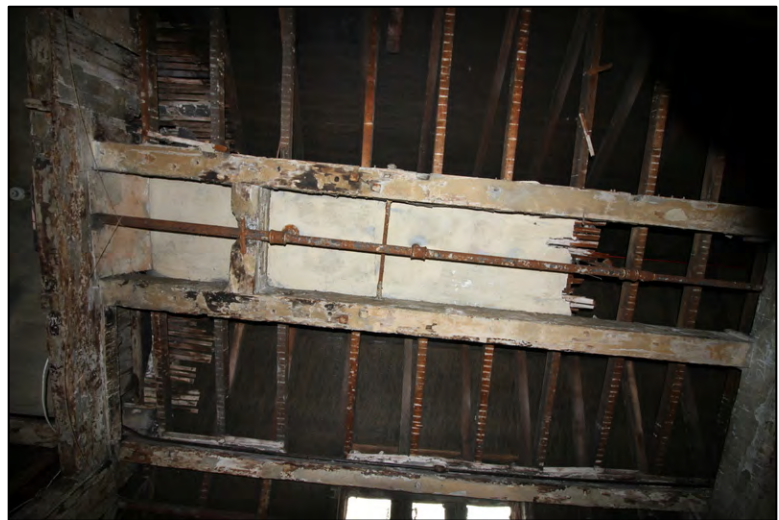
**Description:** Top bracket framing for the upright shaft from the 5<sup>th</sup> floor (**5/25**). It is of similar form to that within the ceiling of the floor below, comprising two large scantling longitudinal beams, and a shorter cross member that would have housed the top bearing to stabilise the shaft,

and house the offtake bevel for the line shaft along the centre of the attic. The area above the framing has a lath and plaster capping, which probably represents a survival of the reduced ceiling level added into the attic to the east, during the refurbishment of the roof in the early-20<sup>th</sup> century. This houses pipes relating to the sprinkler system, which may have been added at the same time, but the position of the latter clearly demonstrates that the upright shaft was redundant by the time of its installation.

**Assessment of Significance:** The framing forms an integral part of the original power system within the mill, and is therefore considered to be of HIGH significance.

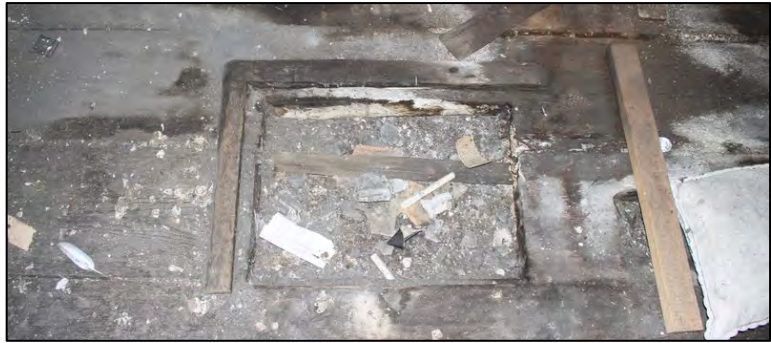
**Description:** Timber-framed aperture with planked infill for a possible secondary upright shaft from the 5<sup>th</sup> floor. This would have been added following the relocation of the 5<sup>th</sup>

floor line shaft to the north, which appears to have happened in the mid-19<sup>th</sup> century. It is possible that the original upright shaft was retained within the modified power transfer system, and it is likely that an upright shaft bearing for translating power to the attic would have had a cast-iron surround by this date.

**Assessment of Significance:** Whilst the feature possibly relates to the upgrading of the power transmission system in the mid-19<sup>th</sup> century, its form suggests that this is unlikely, and is therefore considered to be of MEDIUM significance.

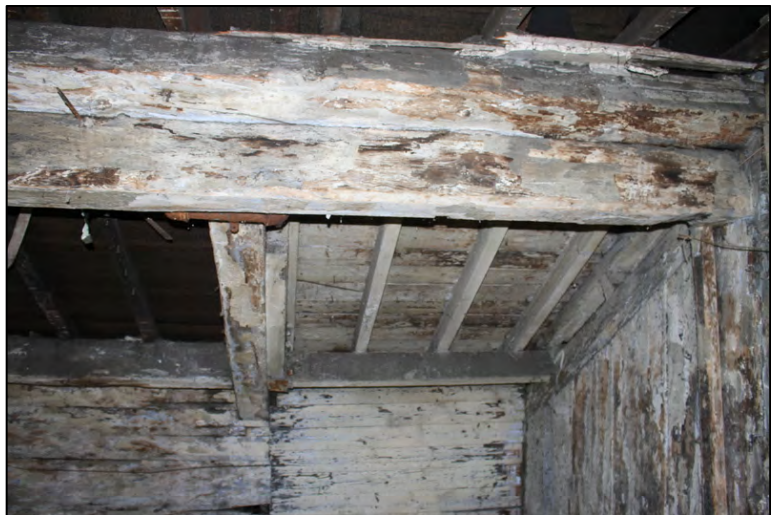
**Description:** The southern side of Bay 3 has several additional timbers added to the roof structure. These comprise an additional principal rafter, placed at the mid-point of the bay, that rises to a longitudinal beam, placed immediately below the upper purlin, and of similar scantling. IT was slung

on an iron bar that lapped over the straining beam of the adjacent trusses, and has a Baltic timber mark (**6/24**) on its northern face, demonstrating it to be of relatively early date.

To the west of the additional principal rafter a box frame was placed beneath the common rafters, which are overlain by horizontal timber sarking planks. The timber-planked eaves partition below (**6/10**) had a vertical butt joint beneath the additional principal rafter, with that in the western part of the bay having been replaced with much narrower boards.

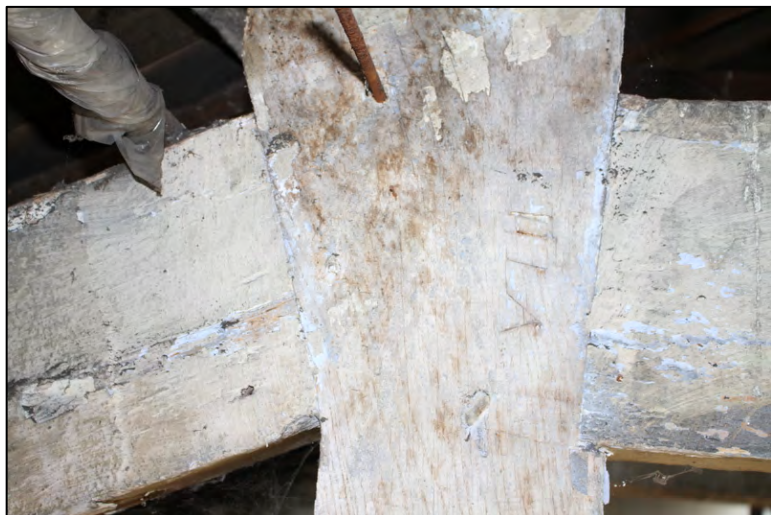
Feature Number: **6/25**

**Description:** Assembly marks on the western faces of both queen posts between Bays 4 and 5. The inscription comprises crudely scraped numerals VIII, signifying the 8<sup>th</sup> truss, and demonstrating that they would have originally been numbered from the eastern end of the building.

**Assessment of Significance:** The mark represents important detail about the construction of the roof of the mill, and is therefore considered to be of HIGH significance.

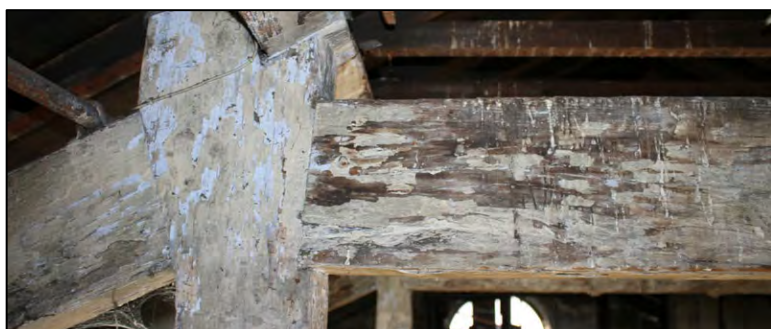
**Description:** Baltic timber mark on the east face of the straining beam of the truss between Bays 4 and 5, near its southern end.

**Assessment of Significance:** The mark demonstrates that the timber is of Baltic softwood, and of relatively early date, and is therefore considered to be of HIGH significance.

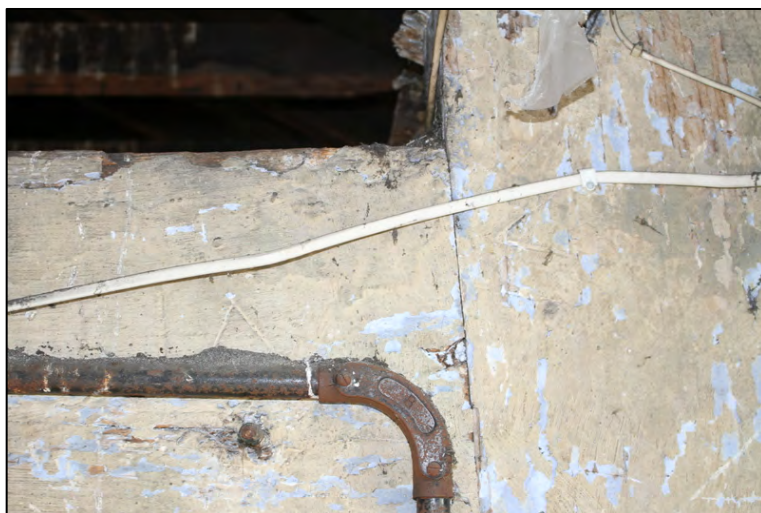
Feature Number: **6/28**

**Description:** Assembly mark on the western face of the southern queen post between Bays 6 and 7, and in an adjacent position on the straining beam. The inscription comprises crudely scraped numerals VI, signifying the 6<sup>th</sup> truss, and demonstrating that they would have originally been numbered from the eastern end of the building.

**Assessment of Significance:** The mark represents important detail about the construction of the roof of the mill, and is therefore considered to be of HIGH significance.

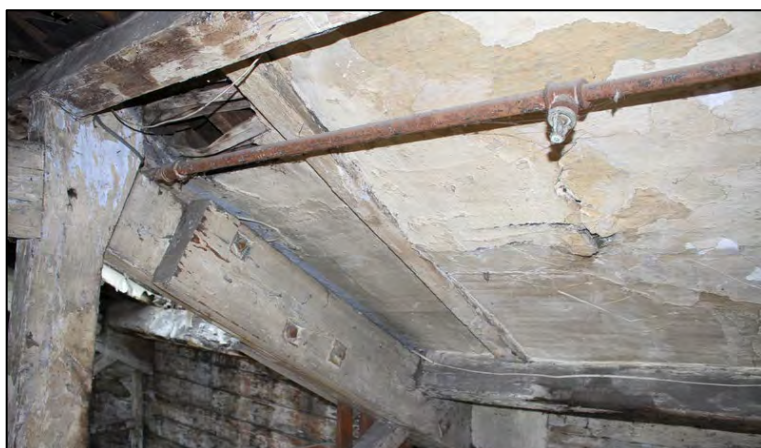
**Description:** A larger scantling rafter within the southern pitch of Bay 7, compared with the majority of late rafters (**6/04**). This was placed adjacent to the truss between Bays 7 and 8, and projects from a late lath and plaster ceiling (**6/30**) that

survives within the eastern part of the bay between the upper and central purlins, unlike the later rafters, that are sealed by the plaster ceiling.

**Assessment of Significance:** The rafter appears to have been part of the original roof structure, and it is likely to survive in its original position, given the different treatment of the rafters associated with the refurbishment of the roof in the early 20<sup>th</sup> century. It is therefore considered to be of HIGH significance, and should be retained during the roof repairs if practical. However, should this prove unfeasible, their loss has been mitigated by 3D laser scanning and photographic recording.

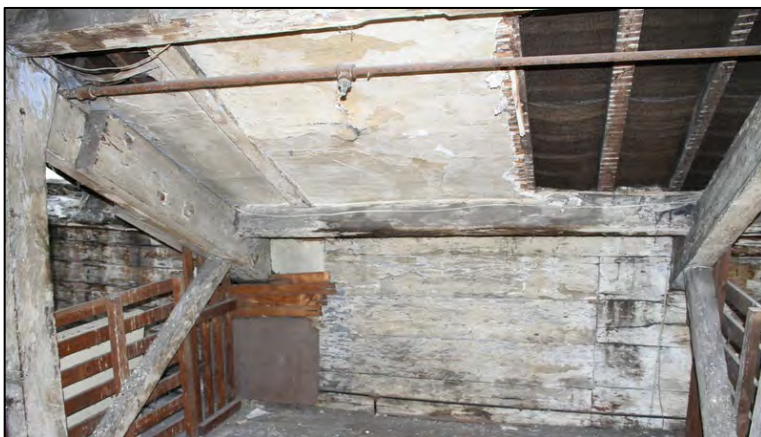
**Description:** The central section of the south pitch of the roof within Bay 7 retains part of a plaster ceiling, above late inserted stairs (5/41), and extending into Bay 8. This differs markedly from the horse-hair and lime-based plaster observed within Bays 1 and 2 (6/14), and to the northern eaves (6/08) being of a harder grey mortar, with charcoal rather than hair inclusions.

**Assessment of Significance:** The small remnant of plastered ceiling appears to represent a partial or full reinstatement of the ceiling of the attic undertaken following the refurbishment of the roof in the early-20<sup>th</sup> century. It is therefore considered to be of LOW significance.

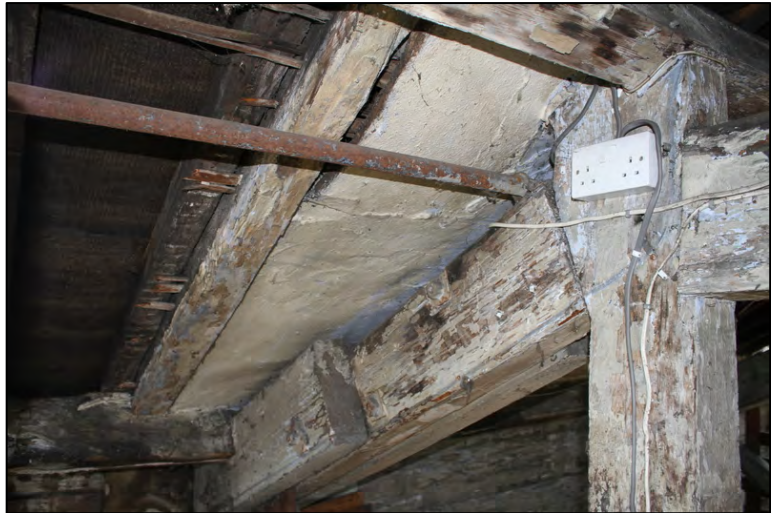
Feature Number: **6/35**

**Description:** A larger scantling rafter within the southern pitch of Bay 8, compared with the majority of late rafters (**6/04**). This was placed adjacent to the truss between Bays 7 and 8, and formed the eastern boundary of the late lath and plaster ceiling (**6/30**). It is of similar scantling to those to the west (**6/17** & **6/29**) and was overlain by a rafter of the refurbished roof (**6/04**).

**Assessment of Significance:** The rafter appears to have been part of the original roof structure, and it is likely to survive in its original position, given the different treatment of the rafters associated with the refurbishment of the roof in the early 20<sup>th</sup> century. It is therefore considered to be of HIGH significance, and should be retained during the roof repairs if practical. However, should this prove unfeasible, their loss has been mitigated by 3D laser scanning and photographic recording.

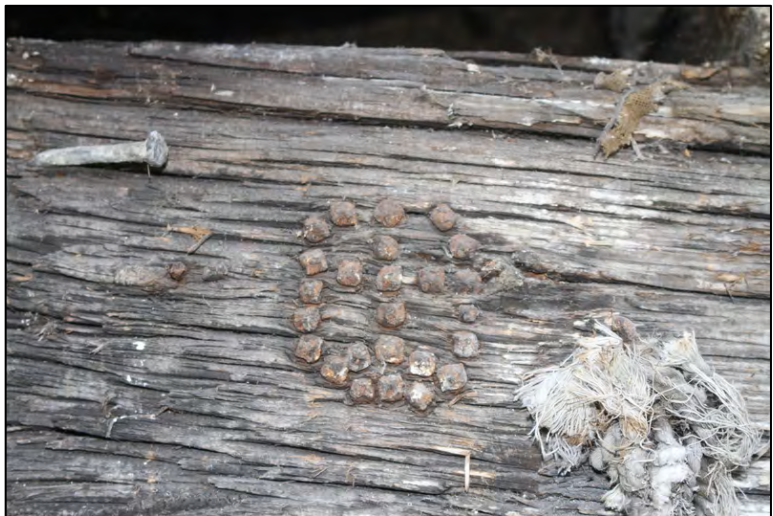
Feature Number: **6/36**

**Description:** A small decorative motif on the central purlin of the southern pitch, placed approximately centrally, and comprising what appears to be a cross within a circle. It was constructed using hobnails, with squared pyramidal heads. Such features are rare, and may represent a

superstition similar that to placing shoes beneath floors to ward off evil spirits. There is also the possibility that it marks a commemoration to the people that died in the collapse of the mill during the latter stages of its construction in 1823.

**Assessment of Significance:** The survival of such features within industrial premises is very rare, and it is therefore considered to be of HIGH significance, and should be protected during the roof repairs.

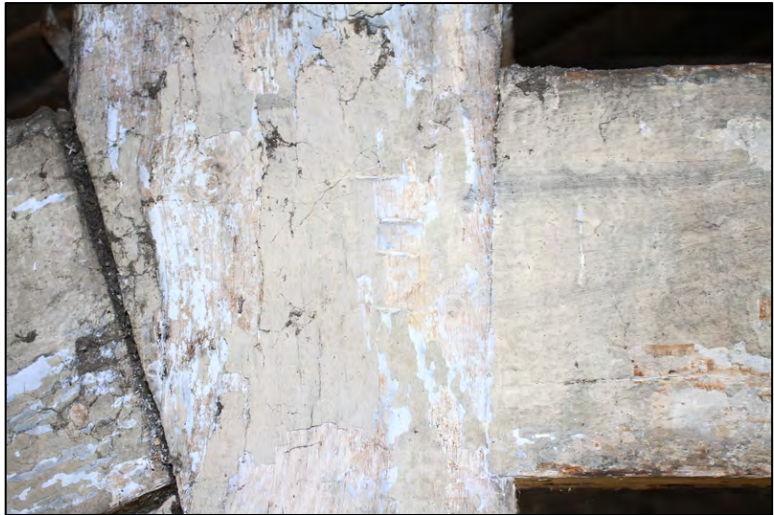
**Description:** Assembly marks on the western face of the northern queen post between Bays 8 and 9. The inscription comprises crudely chiselled numerals IIII, signifying the 4<sup>th</sup> truss, and demonstrating that they would have originally been numbered from the eastern end of the building. The possible

remains of a single 'I' is visible on the adjacent straining beam, suggesting that a full corresponding assembly mark survives beneath significant layers of paint

**Assessment of Significance:** The mark represents important detail about the construction of the roof of the mill, and is therefore considered to be of HIGH significance.

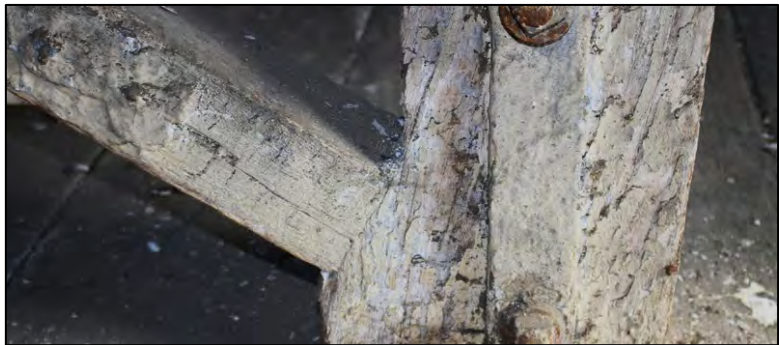
**Description:** Assembly marks on the western face of the southern brace between Bays 8 and 9, close to its joint into the jowled foot of the queen post.

The inscription comprises the

faint, and crudely scratched numerals IIII, matching that on the head of the queen post (**6/37**).

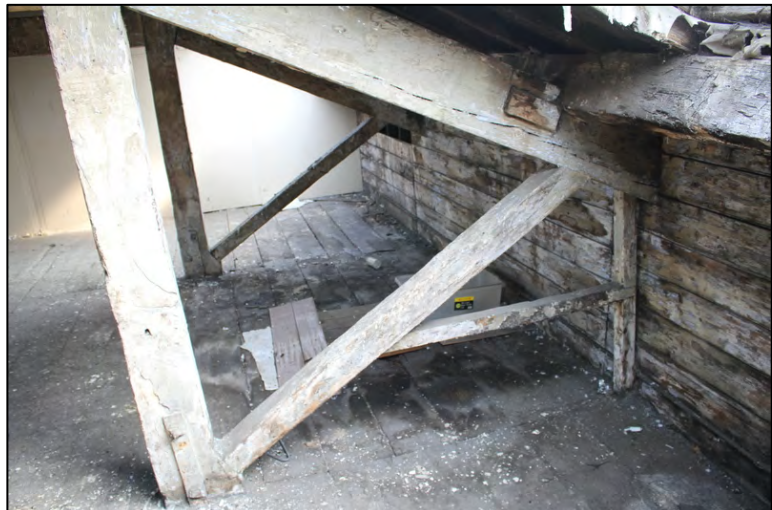
**Description:** Additional slender horizontal member added to the southern brace of the truss between Bays 8 and 9, lap-jointed into a vertical member of similar scantling that braces between the floor and the principal rafter against the timber boarded eaves partition (**6/10**). Possibly added for a

partition similar to that observed between Bays 2 and 3 (**6/19**).

**Assessment of Significance:** The timbers represent a modification to the truss, and are of unknown date. There is little evidence for their possible use, so they are therefore considered to be of LOW significance.

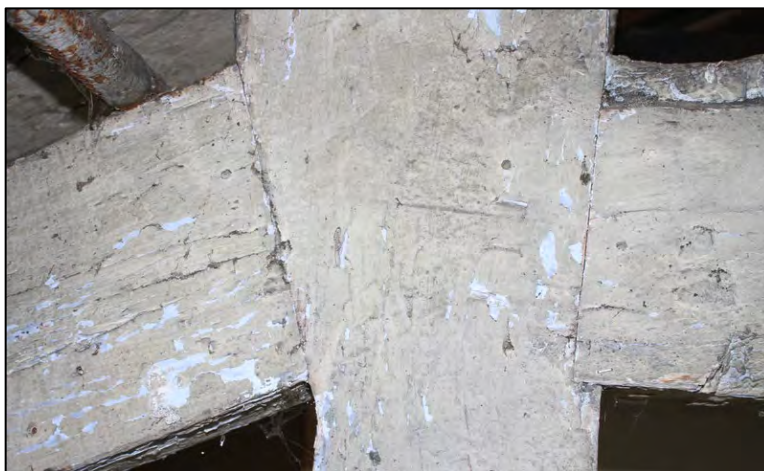
**Description:** Assembly marks on the western face of the northern queen post between Bays 9 and 10. The inscription comprises crudely chiselled numerals III, signifying the 3<sup>rd</sup> truss, and demonstrating that they would have originally been numbered from the eastern end of the building. No evidence for a corresponding assembly mark was visible on the adjacent straining beam.

**Assessment of Significance:** The mark represents important detail about the construction of the roof of the mill, and is therefore considered to be of HIGH significance.

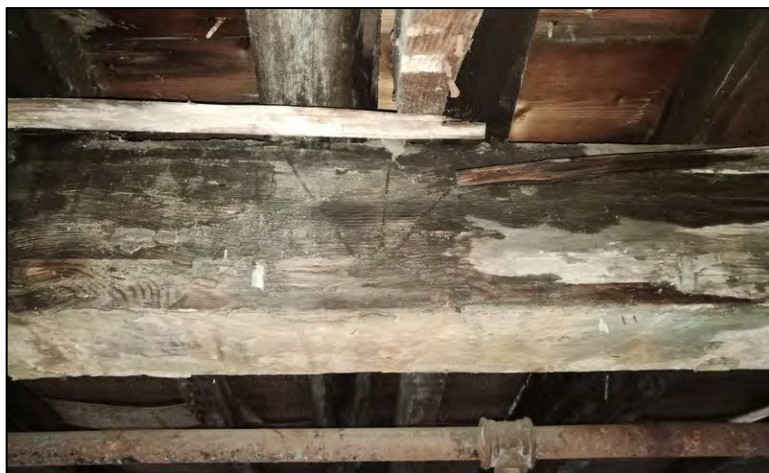
**Description:** Baltic timber mark on the north face of the upper purlin in the south pitch of Bay 9, near its centre.

**Assessment of Significance:** The mark demonstrates that the timber is of Baltic softwood, and of relatively early date, and is therefore considered to be of HIGH significance.

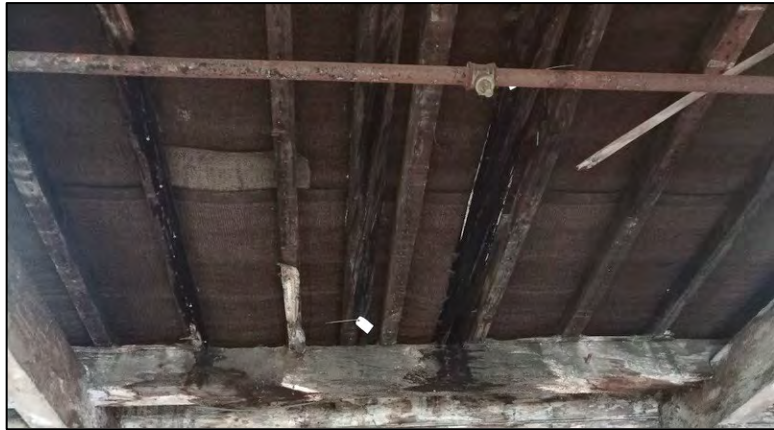
Feature Number: **6/42**

**Description:** A pair of larger scantling rafters within the southern pitch of Bay 9, compared with the majority of late rafters (**6/04**). These were placed centrally within the bay, and comprised only short lengths spanning the central and upper purlins. They are of similar scantling to those to the west (**6/17**, **6/29** & **6/35**) but were almost certainly not in their original position, and had probably also been reduced in length.

**Assessment of Significance:** The rafter appears to have been part of the original roof structure, but appear unlikely to survive in their original position, most probably having been reused during the refurbishment of the roof in the early 20<sup>th</sup> century. They are therefore considered to be of MEDIUM significance, and their loss has been mitigated by 3D laser scanning and photographic recording.
