**SALFORD  
ARCHAEOLOGY**

## **Gazetteer of Features of Heritage Significance**

5<sup>th</sup> & 6<sup>th</sup> Floors,  
Islington Mill, Salford

# *Islington Mill Gazetteer of Features of Heritage Significance*

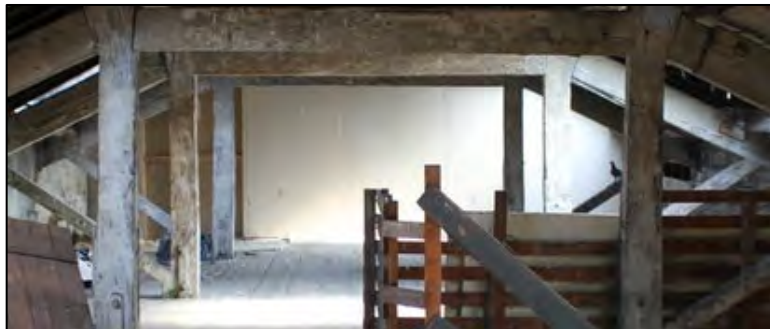
**Description:** A late timber stud partition wall partitioning the eastern two bays from the remainder of the attic. The area to the east was accessible only by the 20<sup>th</sup> century stair tower, whilst that to the east was only accessible from the late central timber stair (**5/41**) following the insertion of this partition. It may be of comparable date to the similar partition on the floor below, **5/63**.

**Assessment of Significance:** The low-quality construction wall detracted from the open space of the 5<sup>th</sup> floor, and is therefore considered to be of LOW significance, but was recorded prior to its removal.

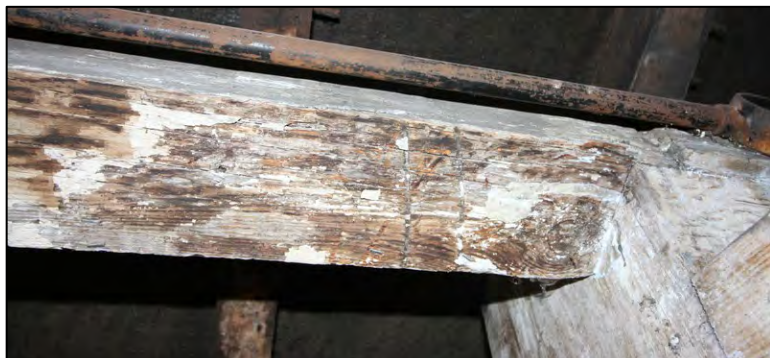
**Description:** Baltic timber mark on the south face of the upper purlin in the north pitch of Bay 11, adjacent to the eastern truss.

**Assessment of Significance:** The mark demonstrates that the timber is of Baltic softwood, and of relatively early date, and is therefore considered to be of HIGH significance.

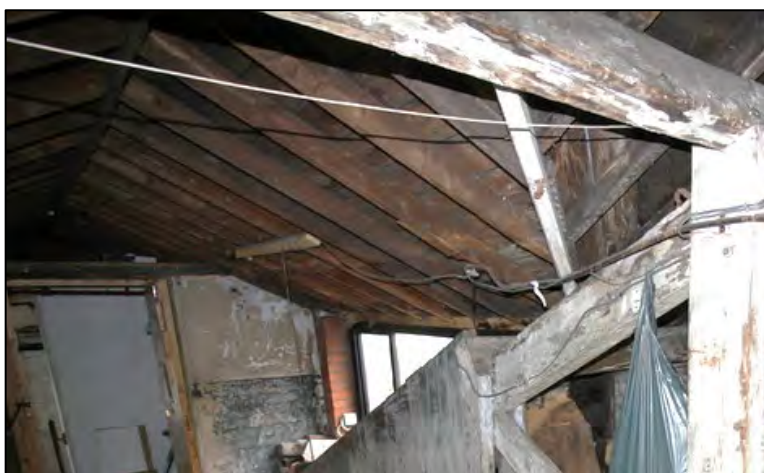
Feature Number: **6/46**

**Description:** Addition of a hip to the southern side eastern bay of the roof, associated with the addition of a stair tower in 1928. It is of similar scantling to the refurbished roof to the main body of the mill, but is less weathered, retaining a brighter colour, suggesting that it is a later remodelling, and that the refurbishment of the roof was taken significantly prior to 1928. It comprises common rafter rising to a ridge board, with a single slender hip purlin added at its angle with the south pitch of the main roof

**Assessment of Significance:** The roof is clearly associated with the addition of the stair tower in 1928. However, it appears to demonstrate phasing between the two roofs, and is therefore considered to be of MEDIUM significance.

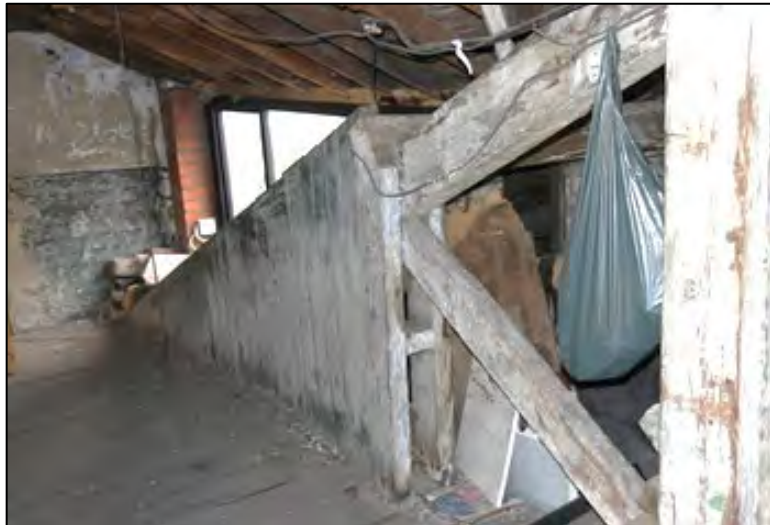
**Description:** angled wall of vertical timber planks masking the foot of the eastern truss, on its eastern side within Bay 12. This was added during the insertion of the stair tower in 1928 to mask the lower part of the southern principal rafter and the eaves of Bay 11.

The partition represents part of the modifications associated with the addition of the stair tower in 1928. However, they form a non-structural detail of the alterations to the main roof associated with this remodelling of the eastern bay, and are therefore considered to be of LOW significance, and will be removed following 3D laser scanning.

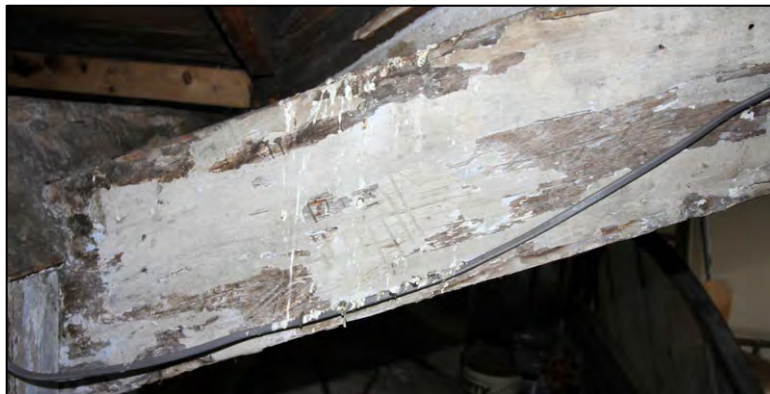
**Description:** Baltic timber mark on the east face of the southern principal rafter of the eastern truss, located above the additional bracing to the lower purlin (**6/45**).

The mark demonstrates that the timber is of Baltic softwood, and of relatively early date, and is therefore considered to be of HIGH significance.

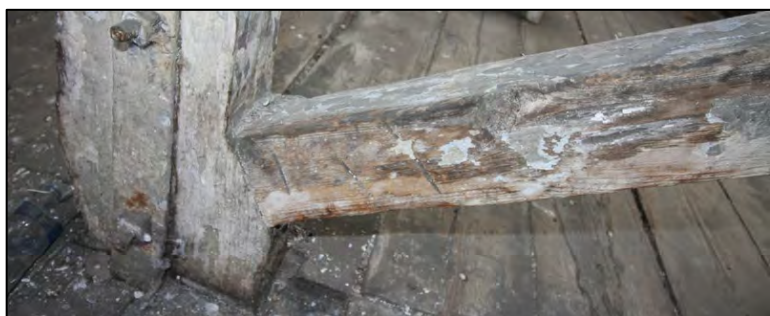
**Description:** Baltic timber mark on the east face of the brace to the northern queen post, at its foot.

**Assessment of Significance:** The mark demonstrates that the timber is of Baltic softwood, and of relatively early date, and is therefore considered to be of HIGH significance.
